About the Bassett Creek Watershed Management Commission (BCWMC)

Plymouth Creek Restoration Project

Plymouth Creek Erosion Issues and Restoration Prioritization

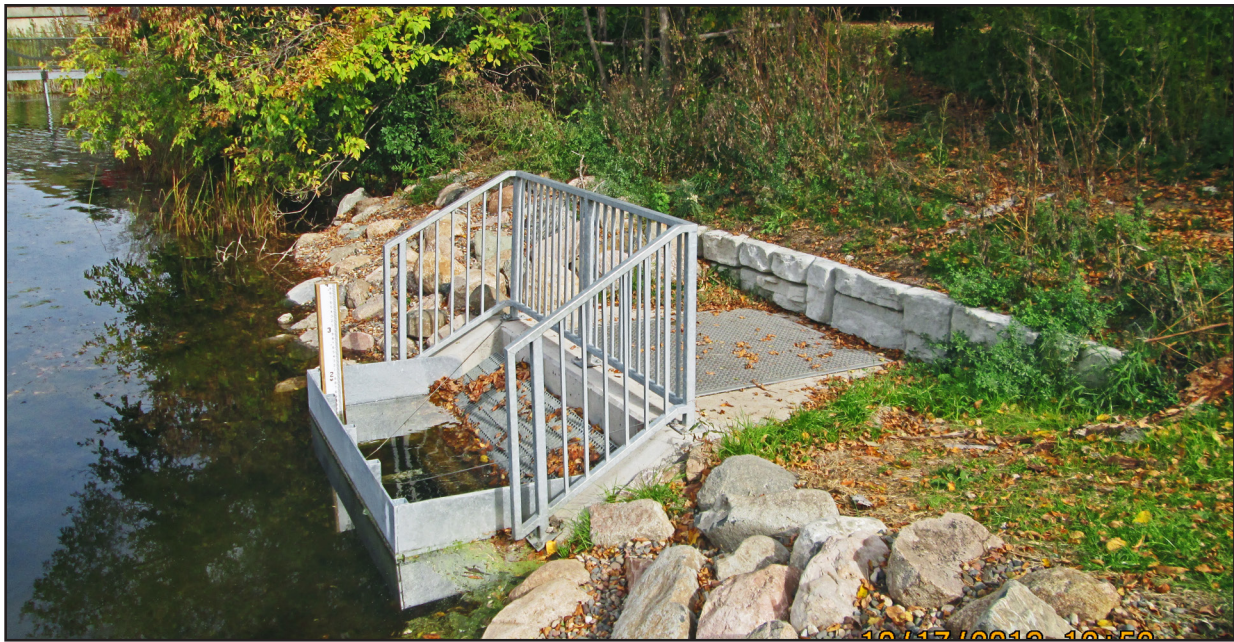
Wirth Lake outlet

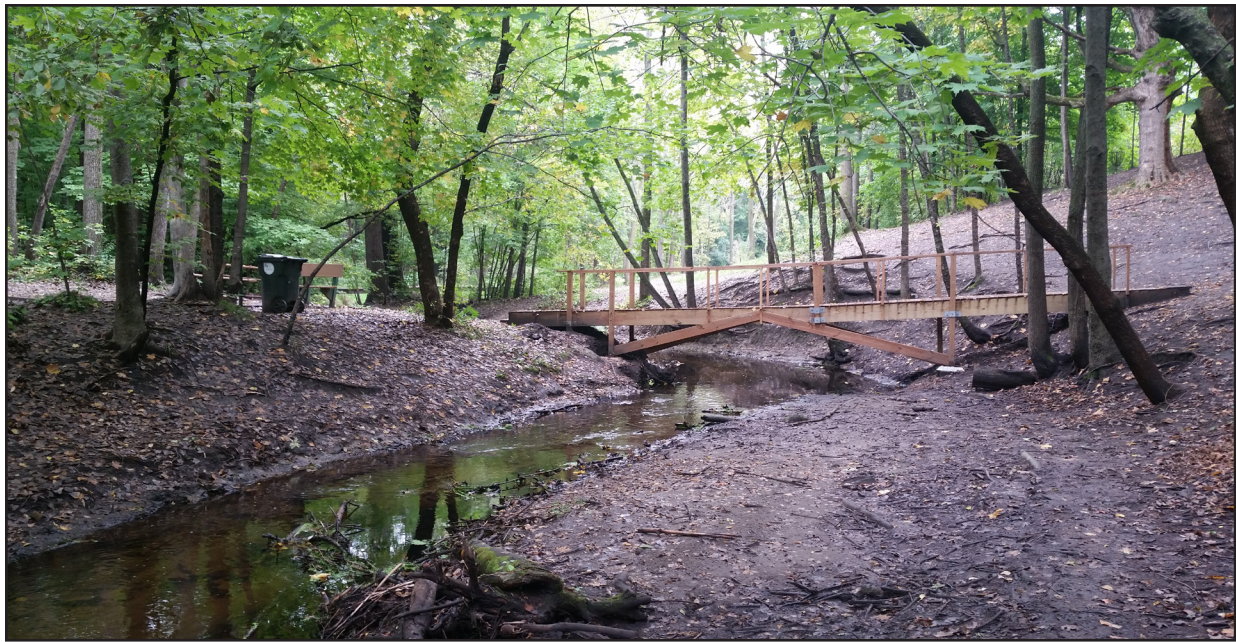
Plymouth Creek restoration (before and after)

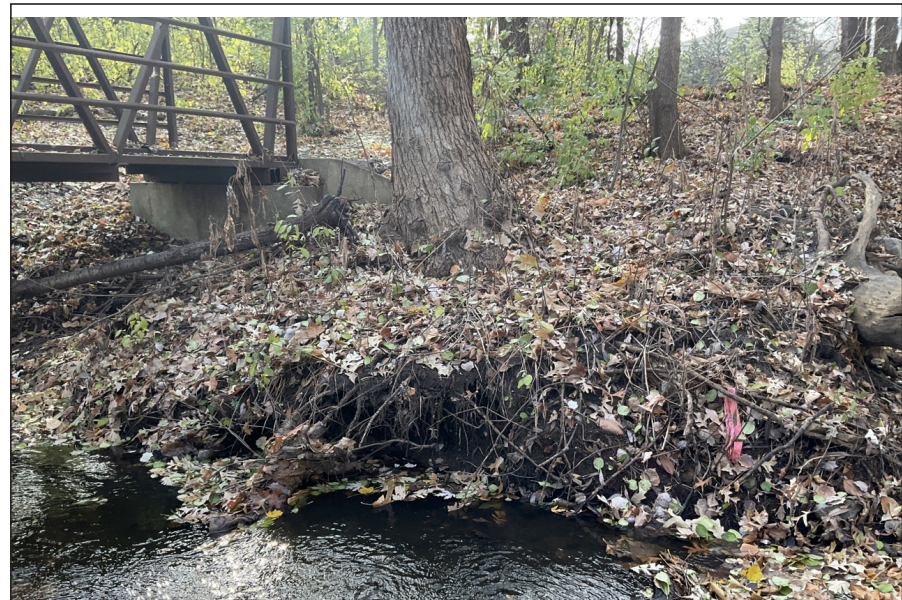
Streambank undercutting

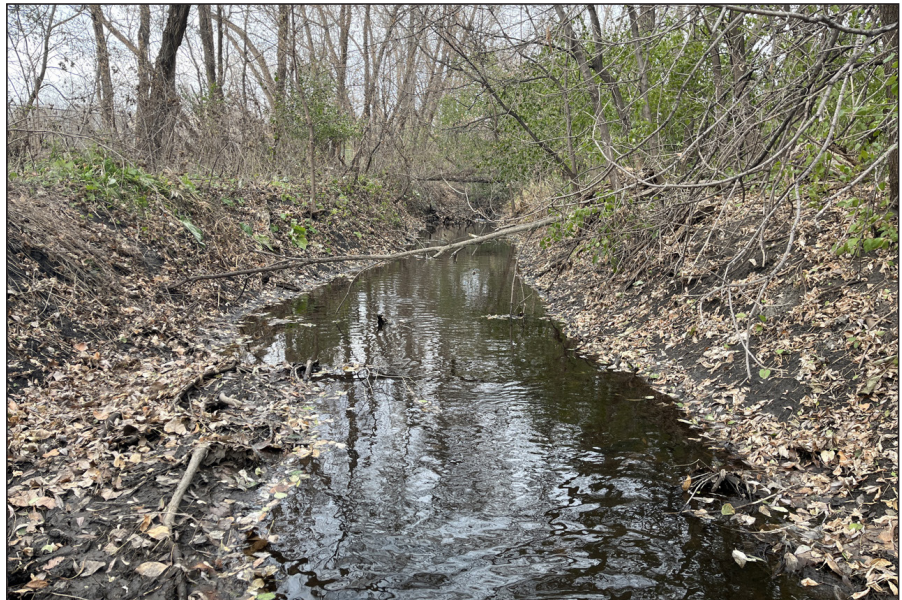
Entrenched channels

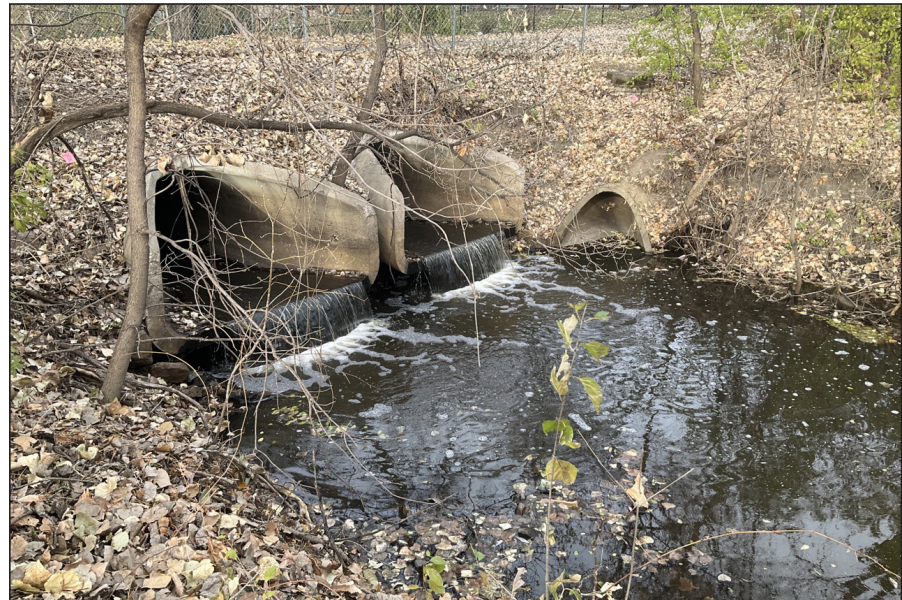
Scour near culverts

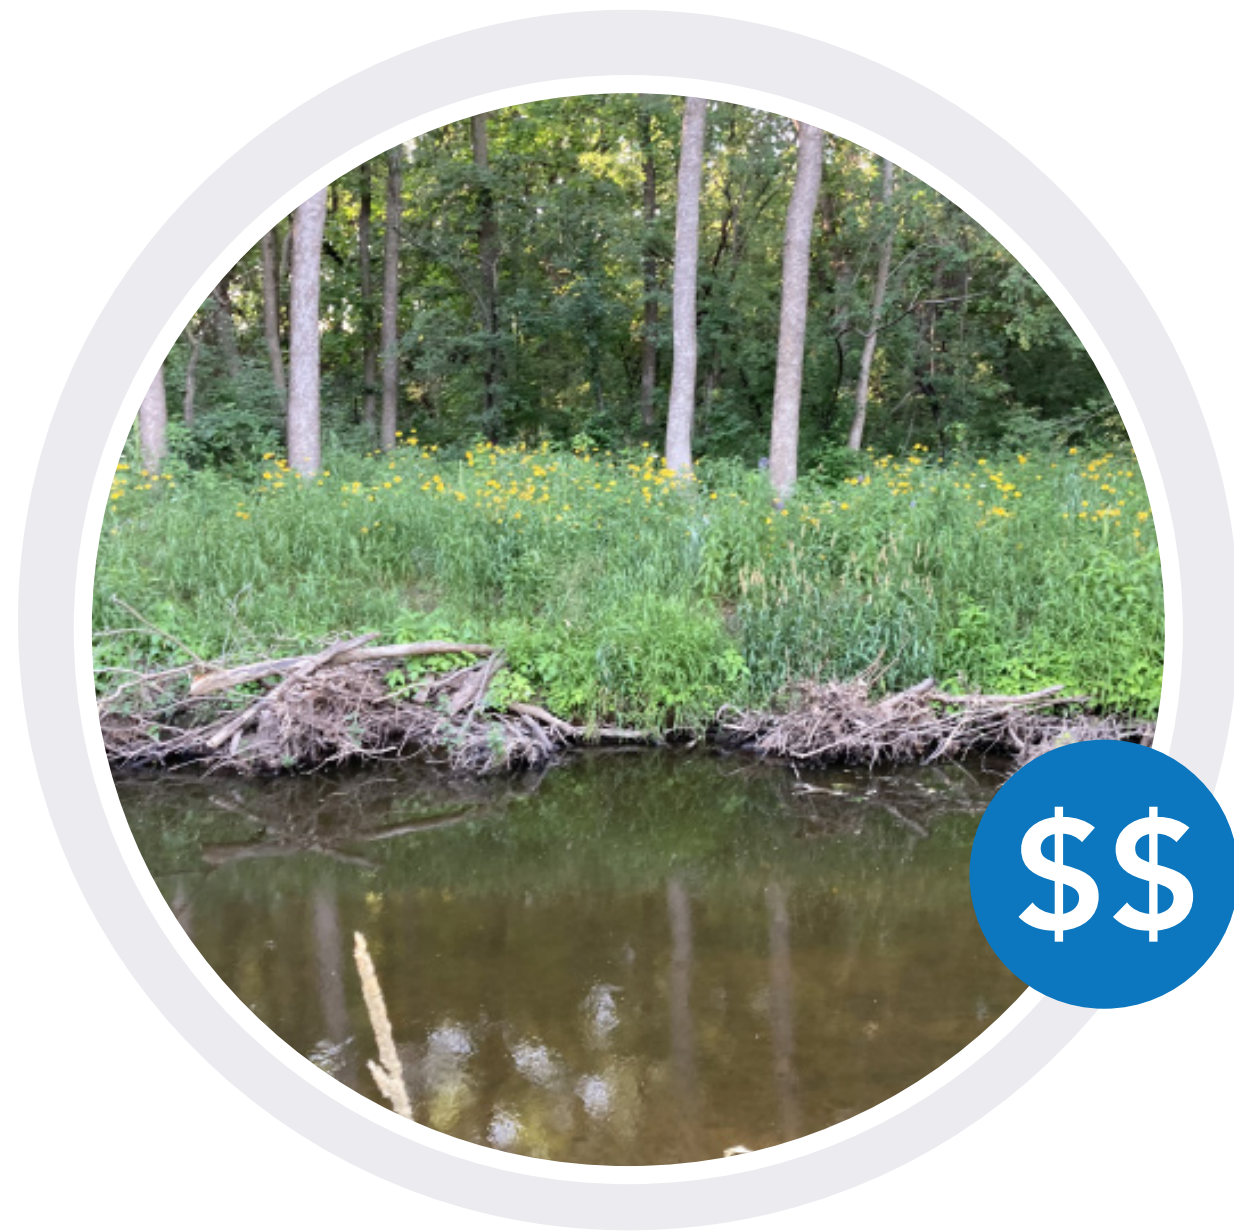
2

Bank stabilization with bioengineering methods

- More erosion protection along the base of the bank, also known as the bank toe
- Bioengineering and vegetation features can improve in-stream and bank habitat

- Requires establishment period for vegetation features
- Moderate grading can increase construction costs, bank disturbance, and potential tree removal

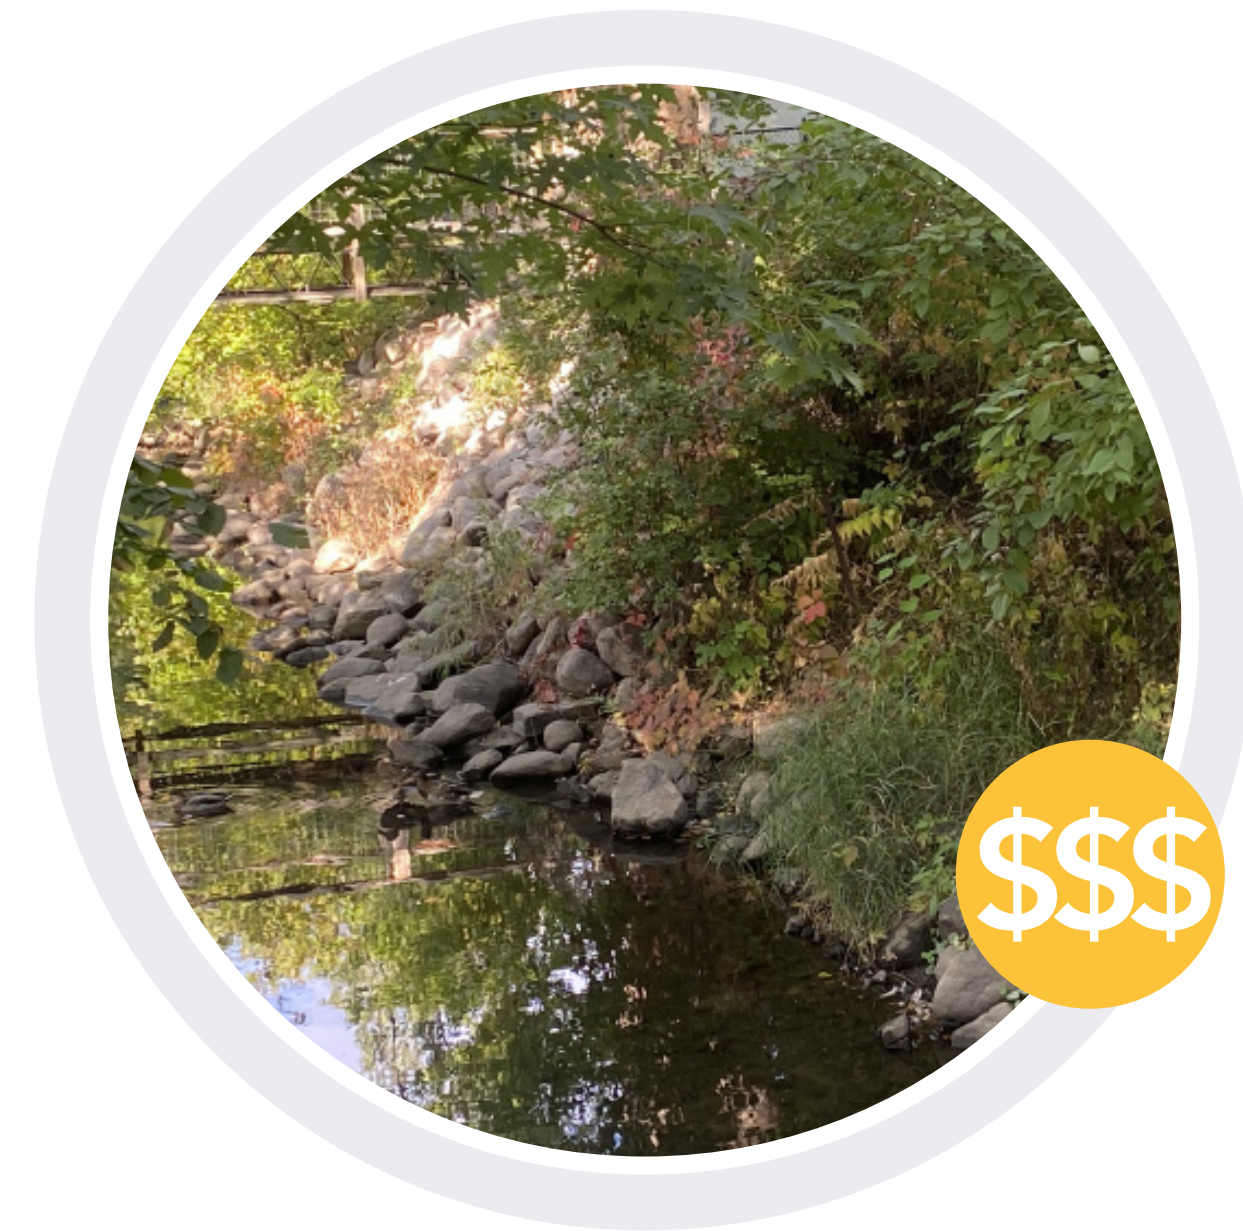
3

Bank grading with riprap and vegetation establishment

- Riprap allows for the most protection against damaging (high shear stress) flows
- Immediate stabilization of eroding areas

- Riprap provides minimal in-stream or bank habitat
- Riprap and grading are more cost intensive
- Most bank disturbance during construction, and potential tree removal

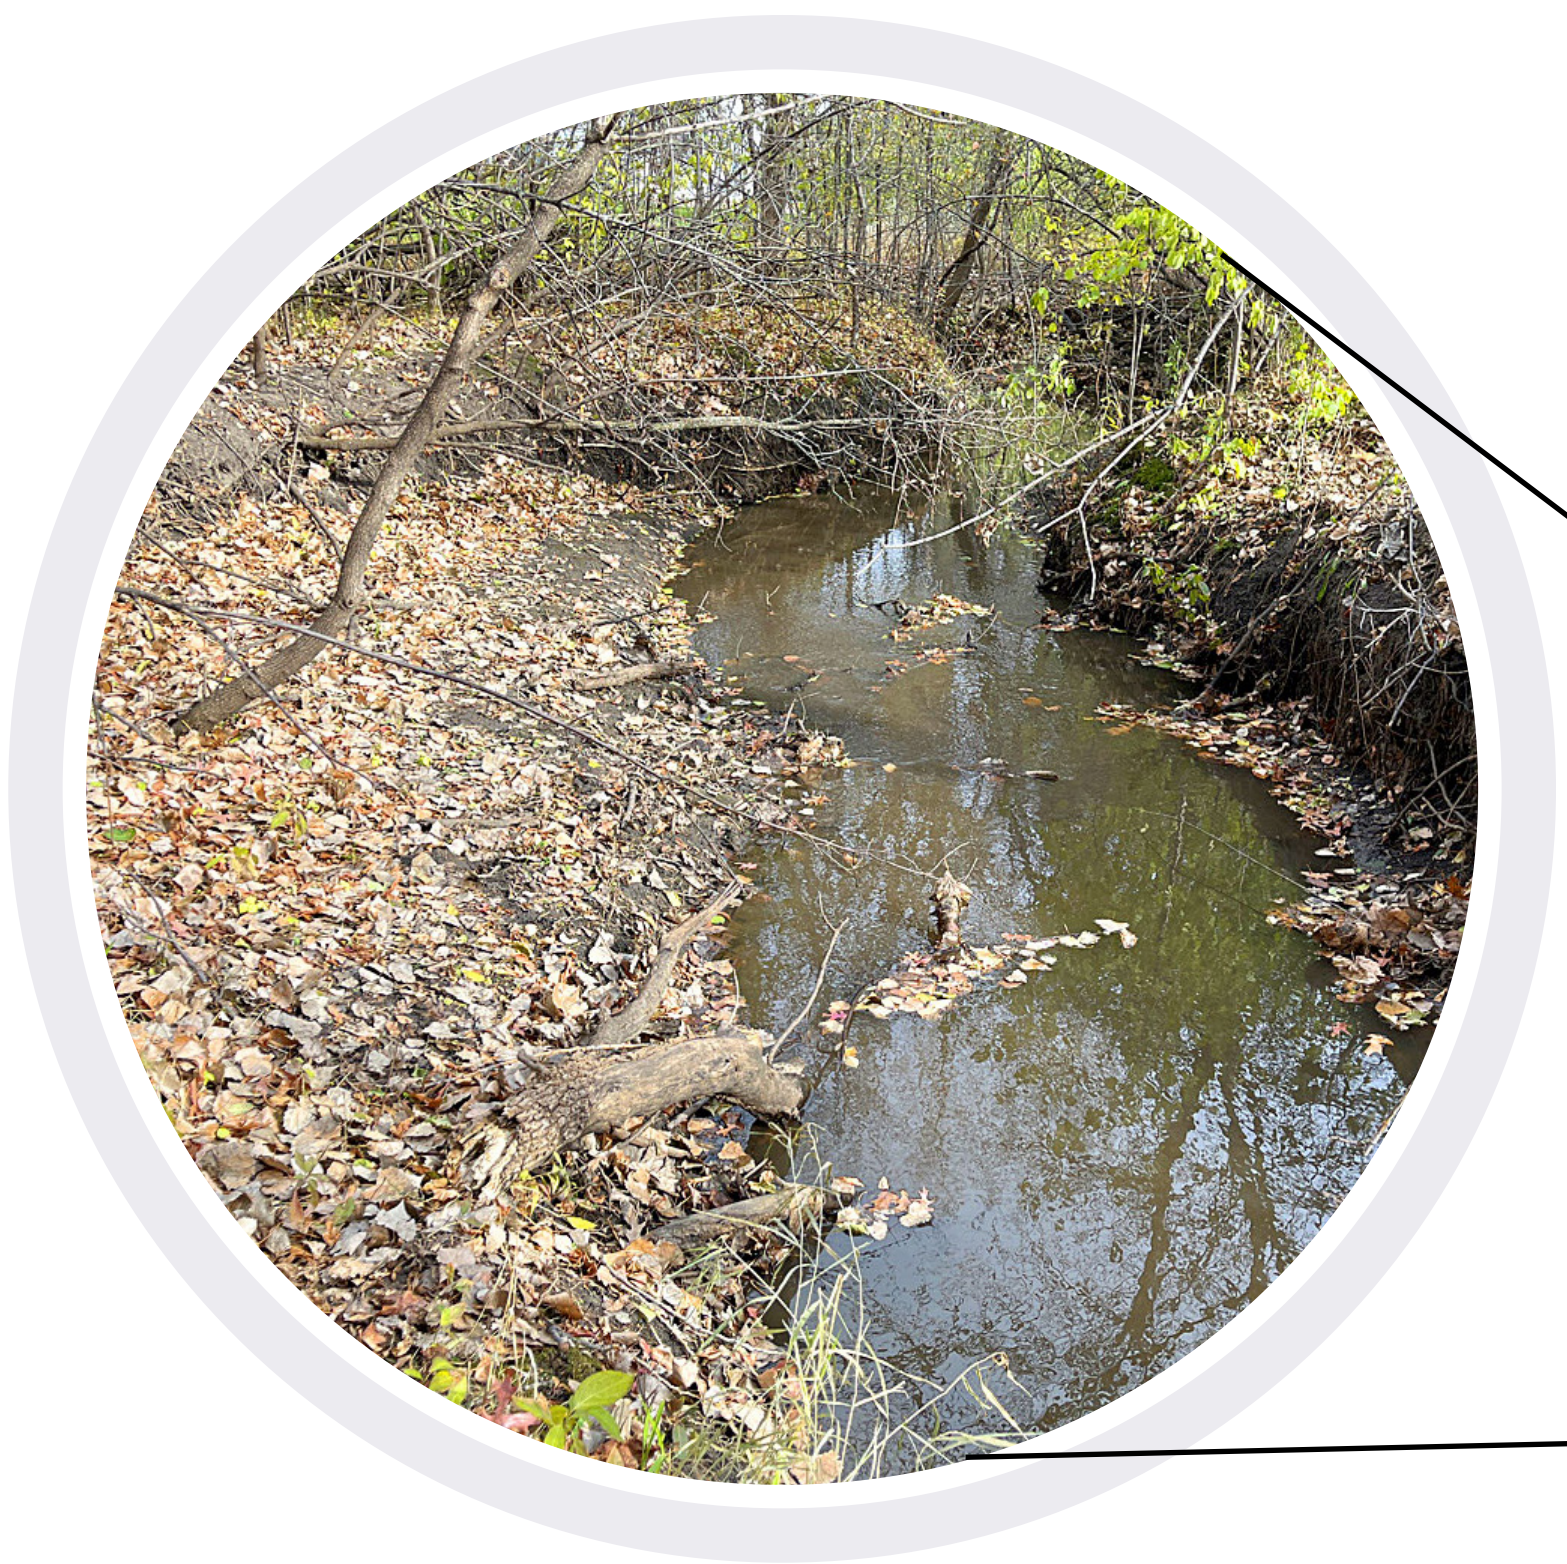
Preliminary Concept for Reach 1, Dunkirk Lane to Yuma Lane

- Regrade channel and stream banks to improve floodplain connection and soften tight curves
- Stabilize stream bank toe with rock riprap, coconut-fiber (coir) log, or root wads
- Stabilize stream bank with vegetative material (seed, live plugs, shrubs, and/or live cuttings)
- Remove invasive buckthorn within riparian zone and replace with native plantings

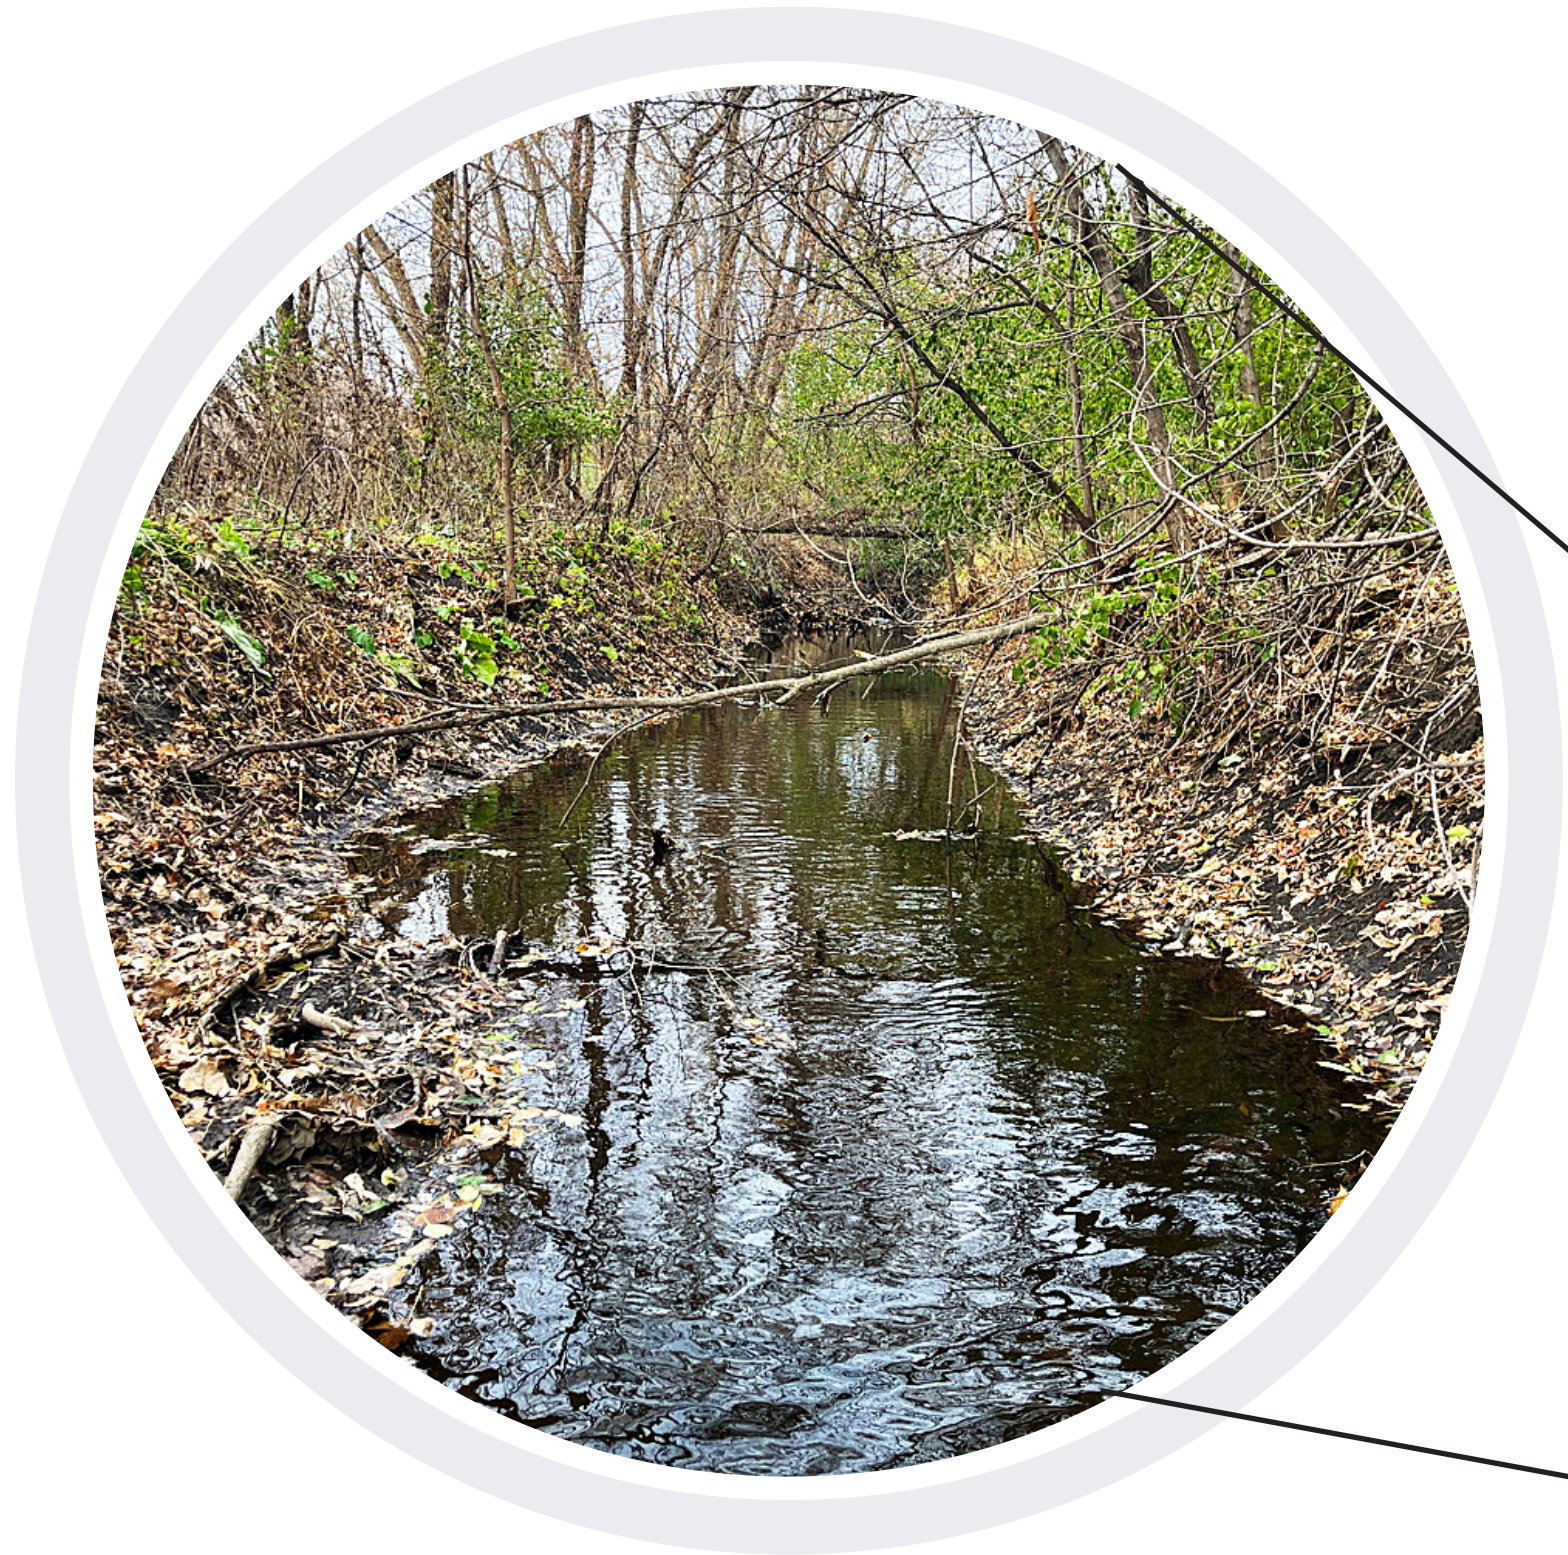
Preliminary Concept for Reach 2, Yuma Lane to Vicksburg Road

- Regrade channel and stream banks to improve floodplain connection
- Install rock vanes to maintain channel grade and route erosive flows away from stream banks
- Stabilize stream bank with vegetative material (seed, live plugs, shrubs, and/or live cuttings)
- Remove invasive buckthorn within riparian zone and replace with native plantings

* See channel re-alignment board for potential stream meander layout next to school.

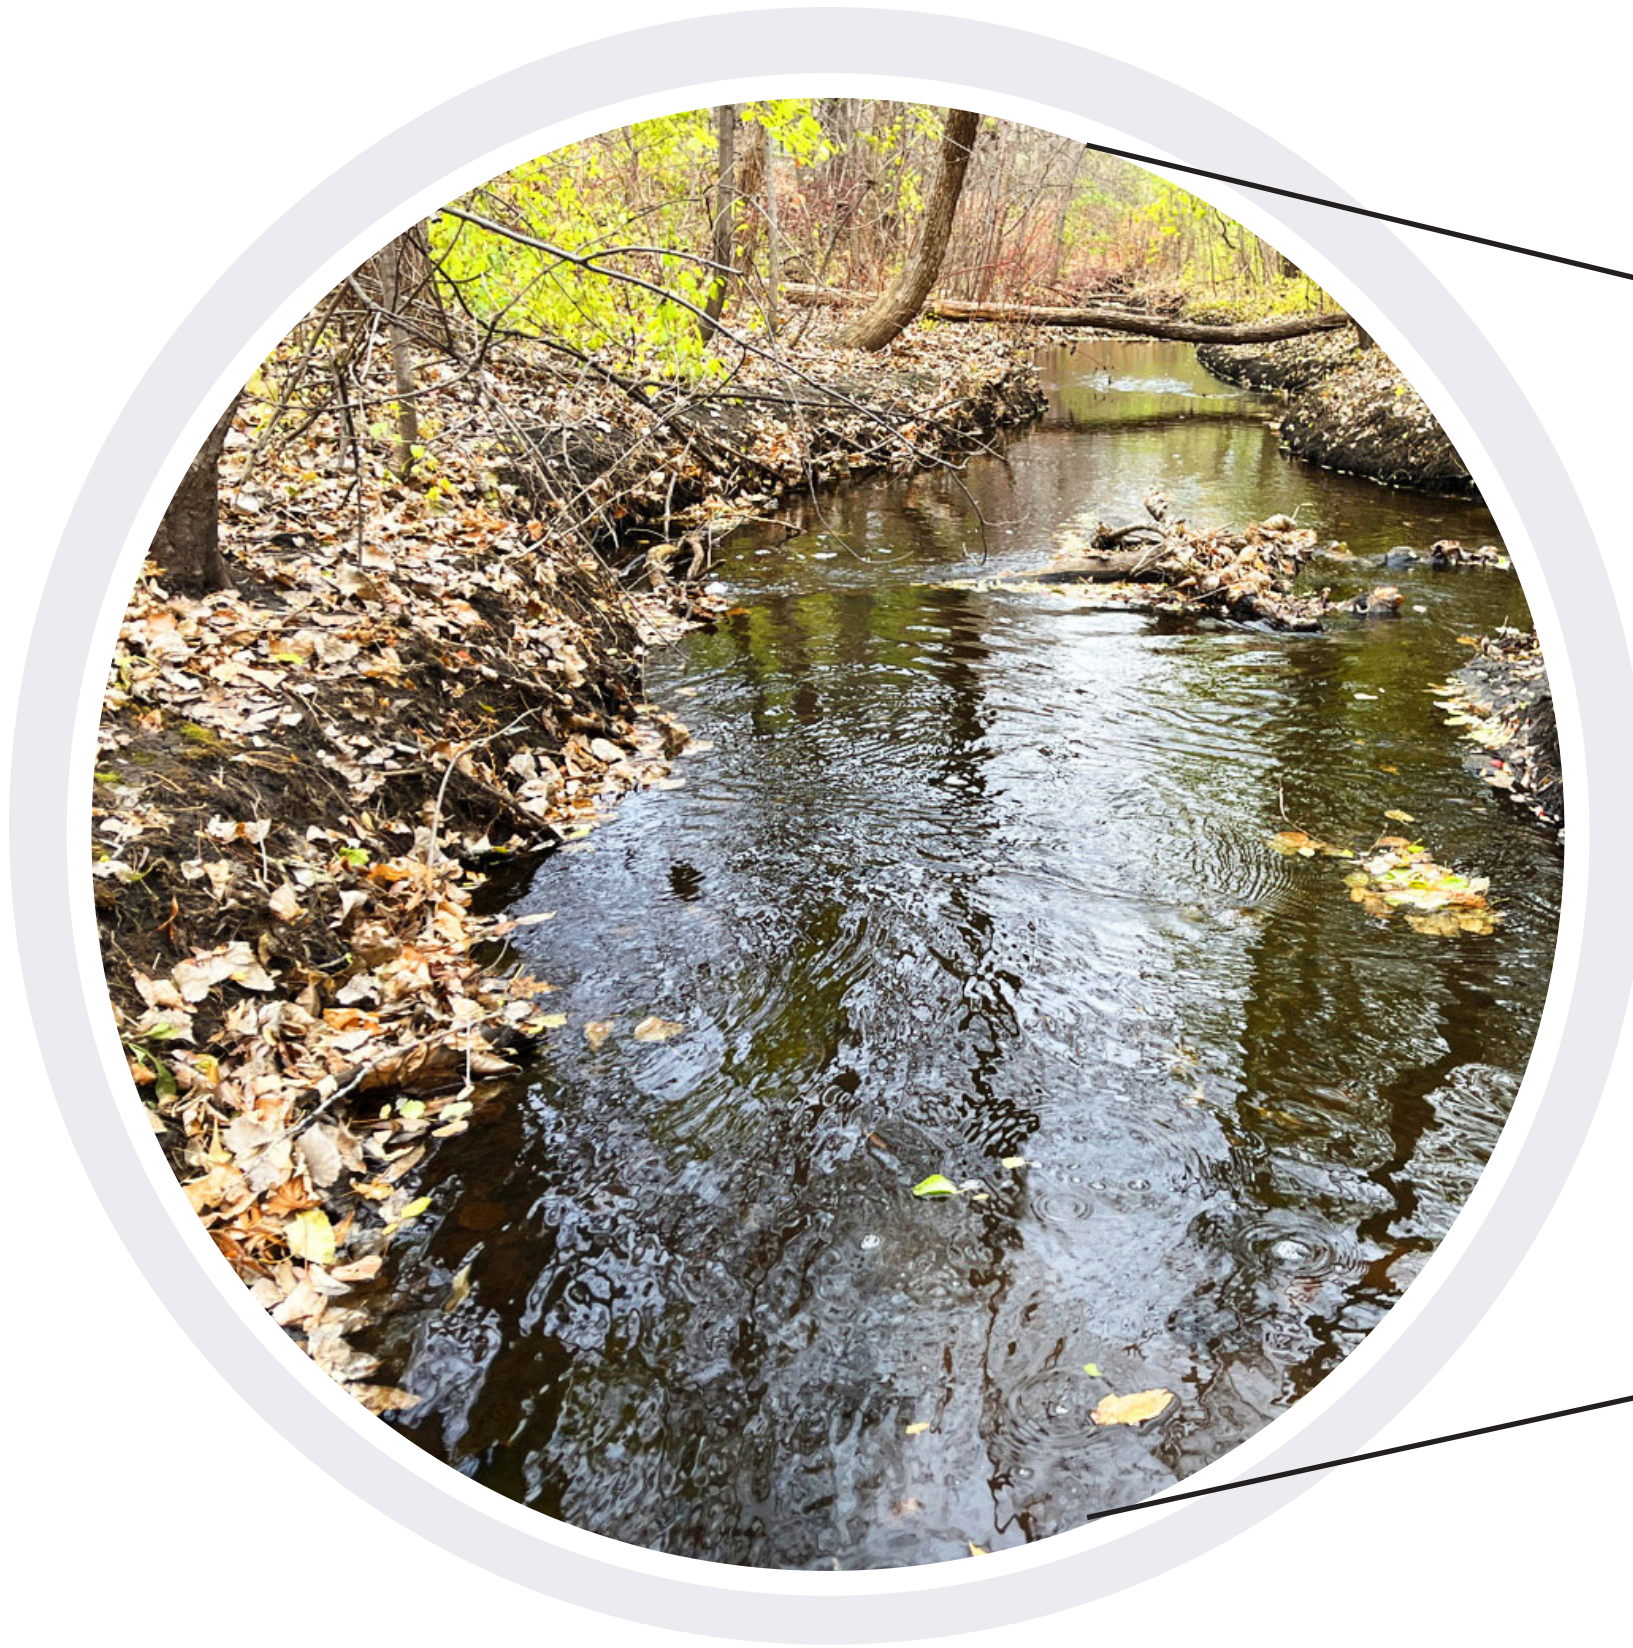
Preliminary Concept for Reach 3, Vicksburg Road to Rockford Road

- Install rock vanes to maintain channel grade and J-hook vanes to route erosive flows away from stream banks
- Stabilize culvert outlets with grading, riprap, erosion control blanket, and/or live plugs and seed
- Remove invasive buckthorn within riparian zone and replace with native plantings

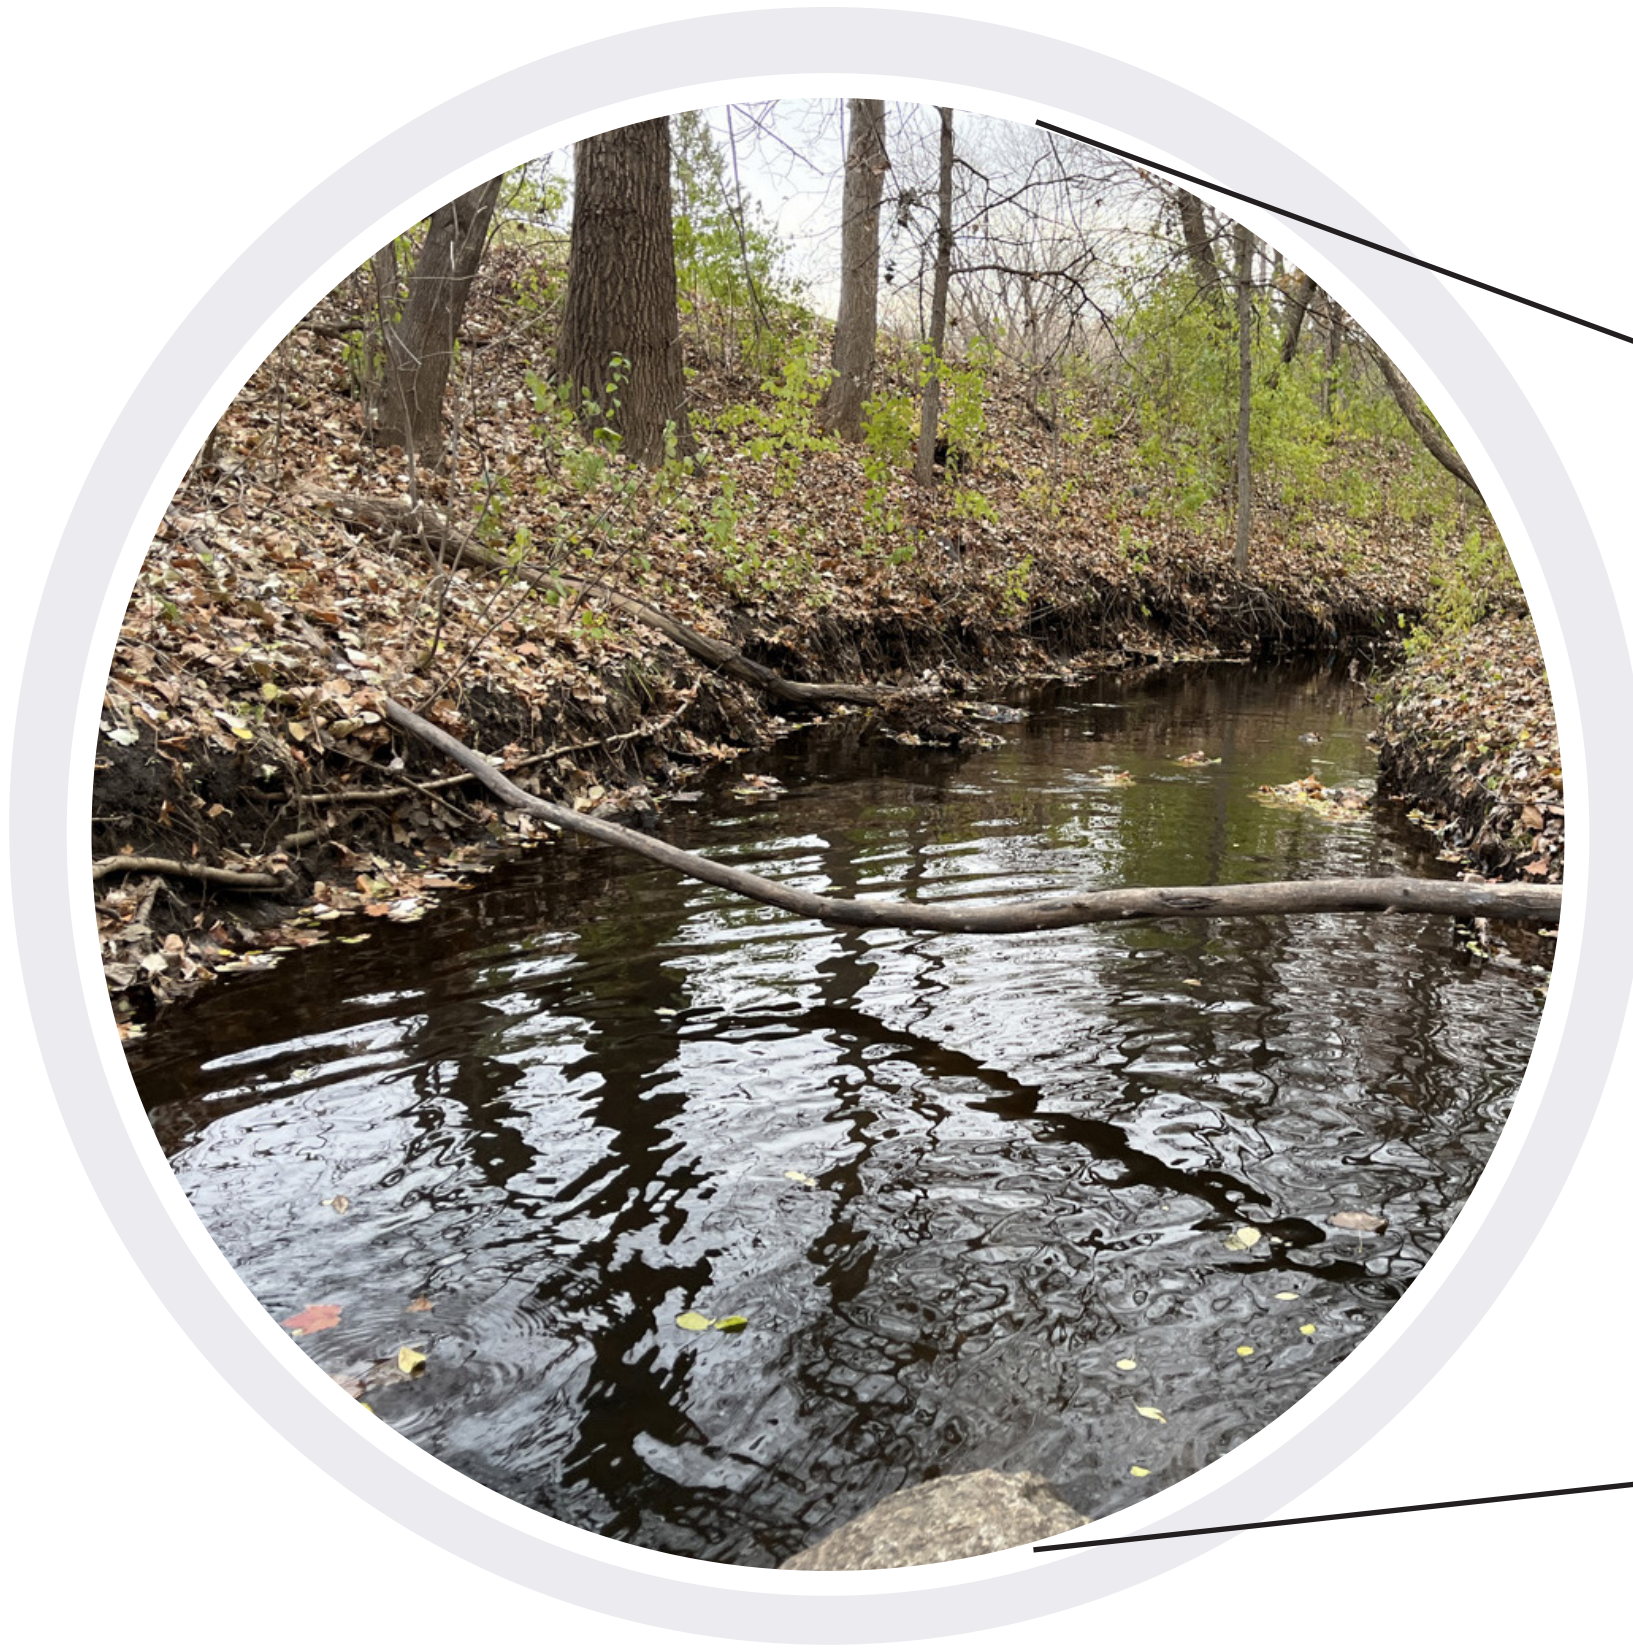
Preliminary Concept for Reach 4, Rockford Road to 38th Avenue

- Install rock vanes to maintain channel grade and J-hook vanes to route erosive flows away from stream banks
- Grade banks, place erosion control blanket and live plugs with live stakes and seeding to enhance floodplain
- Remove invasive buckthorn within riparian zone and replace with native plantings

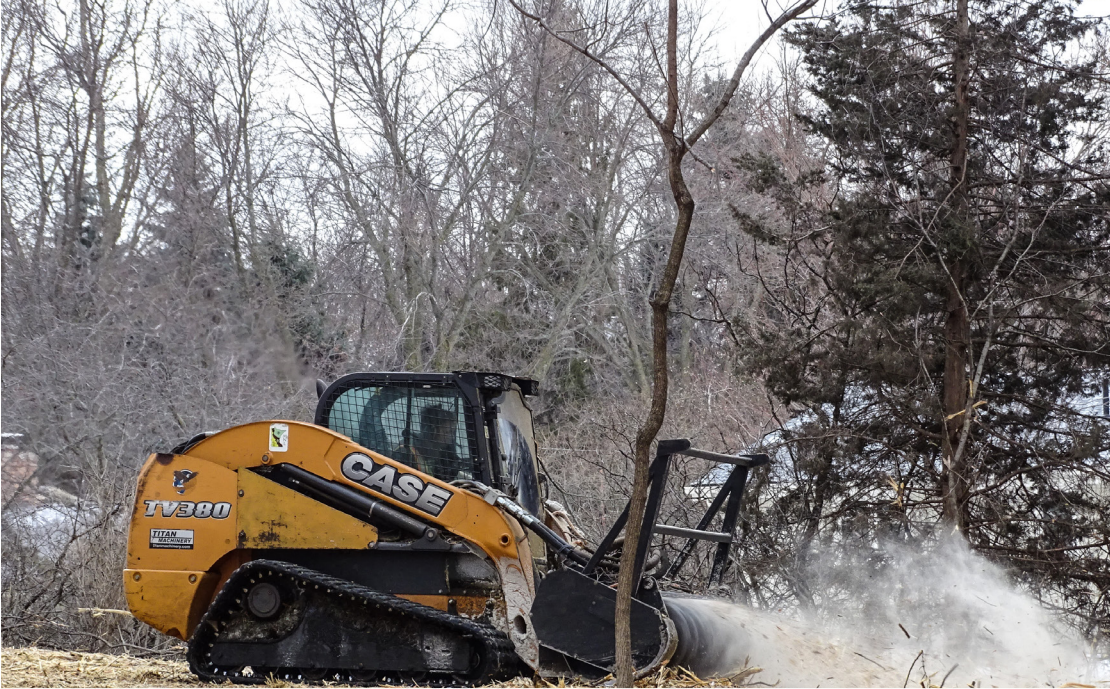
Example of Tree Removal: **Forestry Mower Clearing Trees**
