# **Four Seasons Mall Water Quality Improvement Feasibility Report**

# Four Seasons Mall Water Quality Improvement Feasibility Report

**Wenck File #1756-05**

**CITY OF PLYMOUTH, MN**  
3400 Plymouth Boulevard  
Plymouth, MN 55447-1482

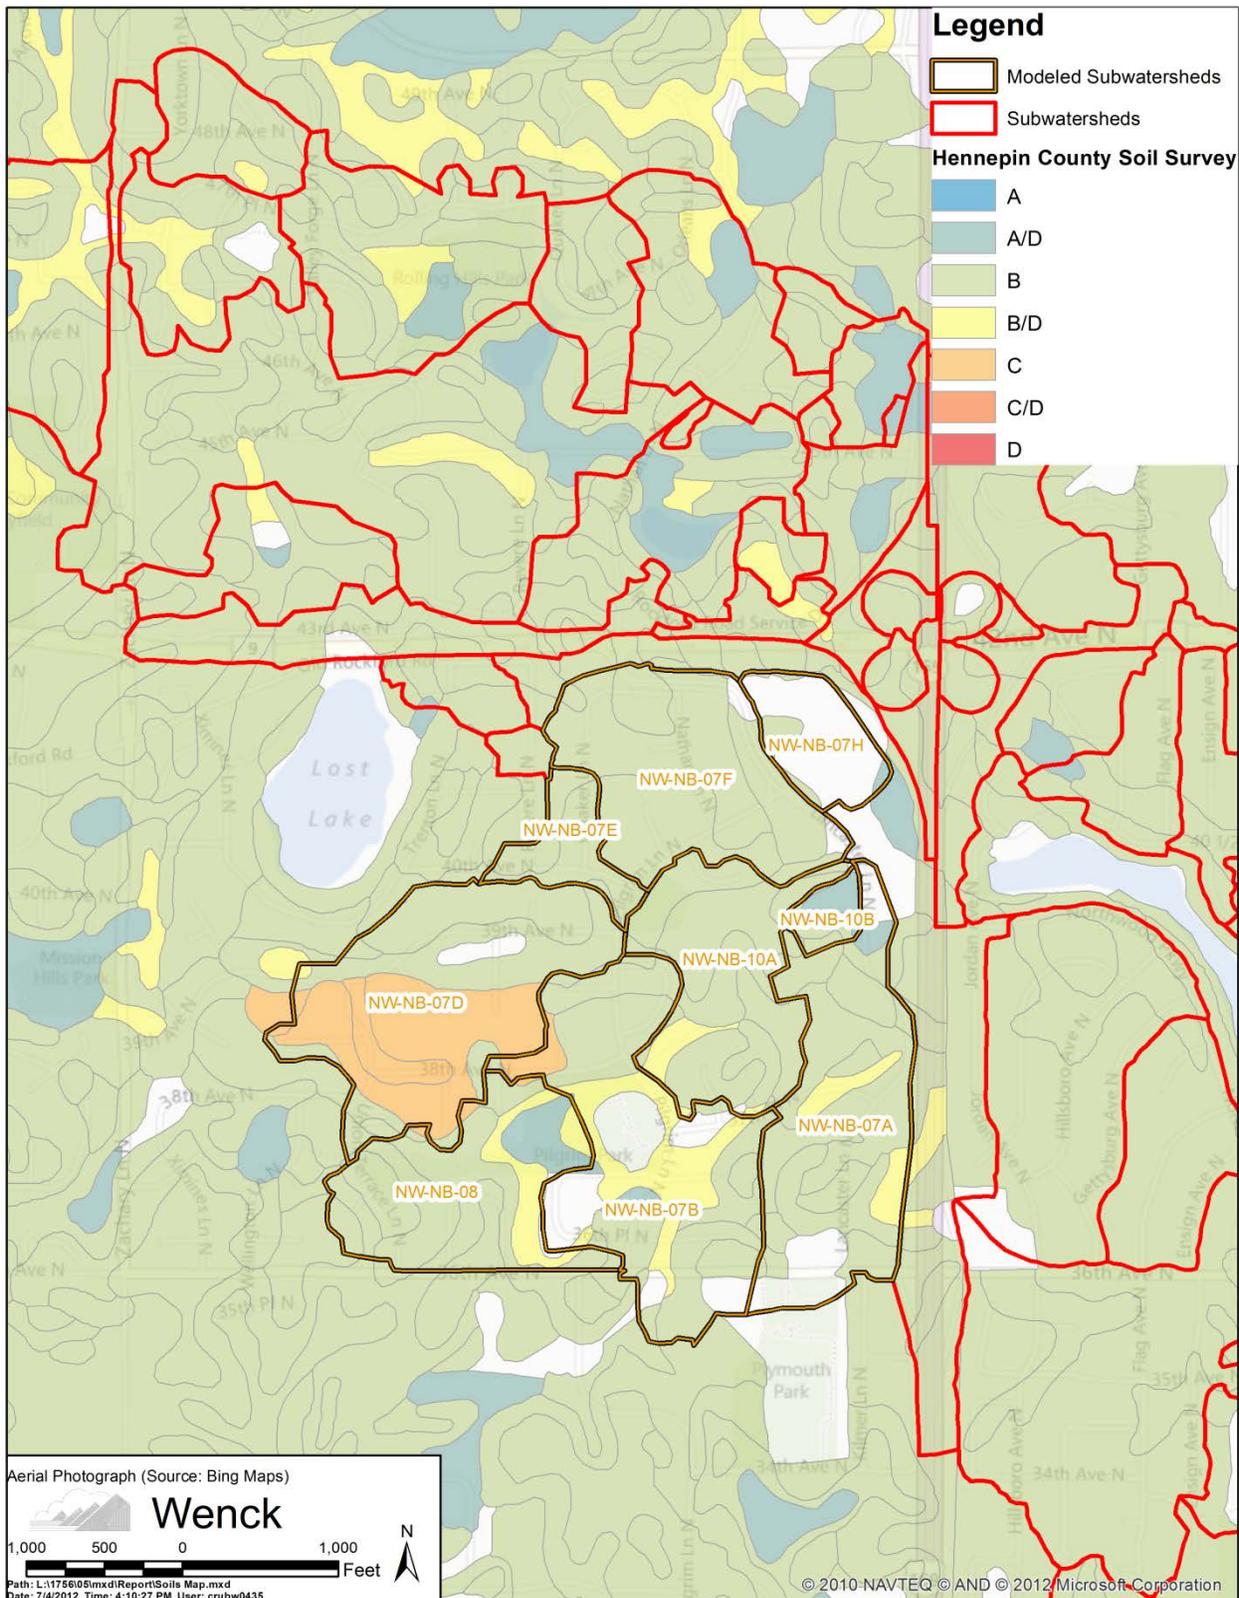
**Figure 2.2. SSURGO Soils Inventory for Hennepin County in the Project Area.**

The Hennepin County Soil Survey identified the hydric soil groups in the project area as predominantly B soils with some B/D and C soils in the southwest (Figure 2.2). Hydric soil group B is composed of soil series Angus and Lester, which are classified as well drained soils. Infiltration rates associated with soils groups B, D, and C soils According to the *Minnesota Stormwater Manual* (MPCA, 2008) are shown in Table 2.1. The proposed stormwater ponds are located in these soils.

Infiltration practices are not a viable option for treatment within the watershed based on mediocre drainability of the soils, limited space for BMPs based on the size of the subwatersheds, and a high groundwater table in the suggested locations. The predominant HSG in the area is B soils with medium to poor drainage (Figure 2.2).

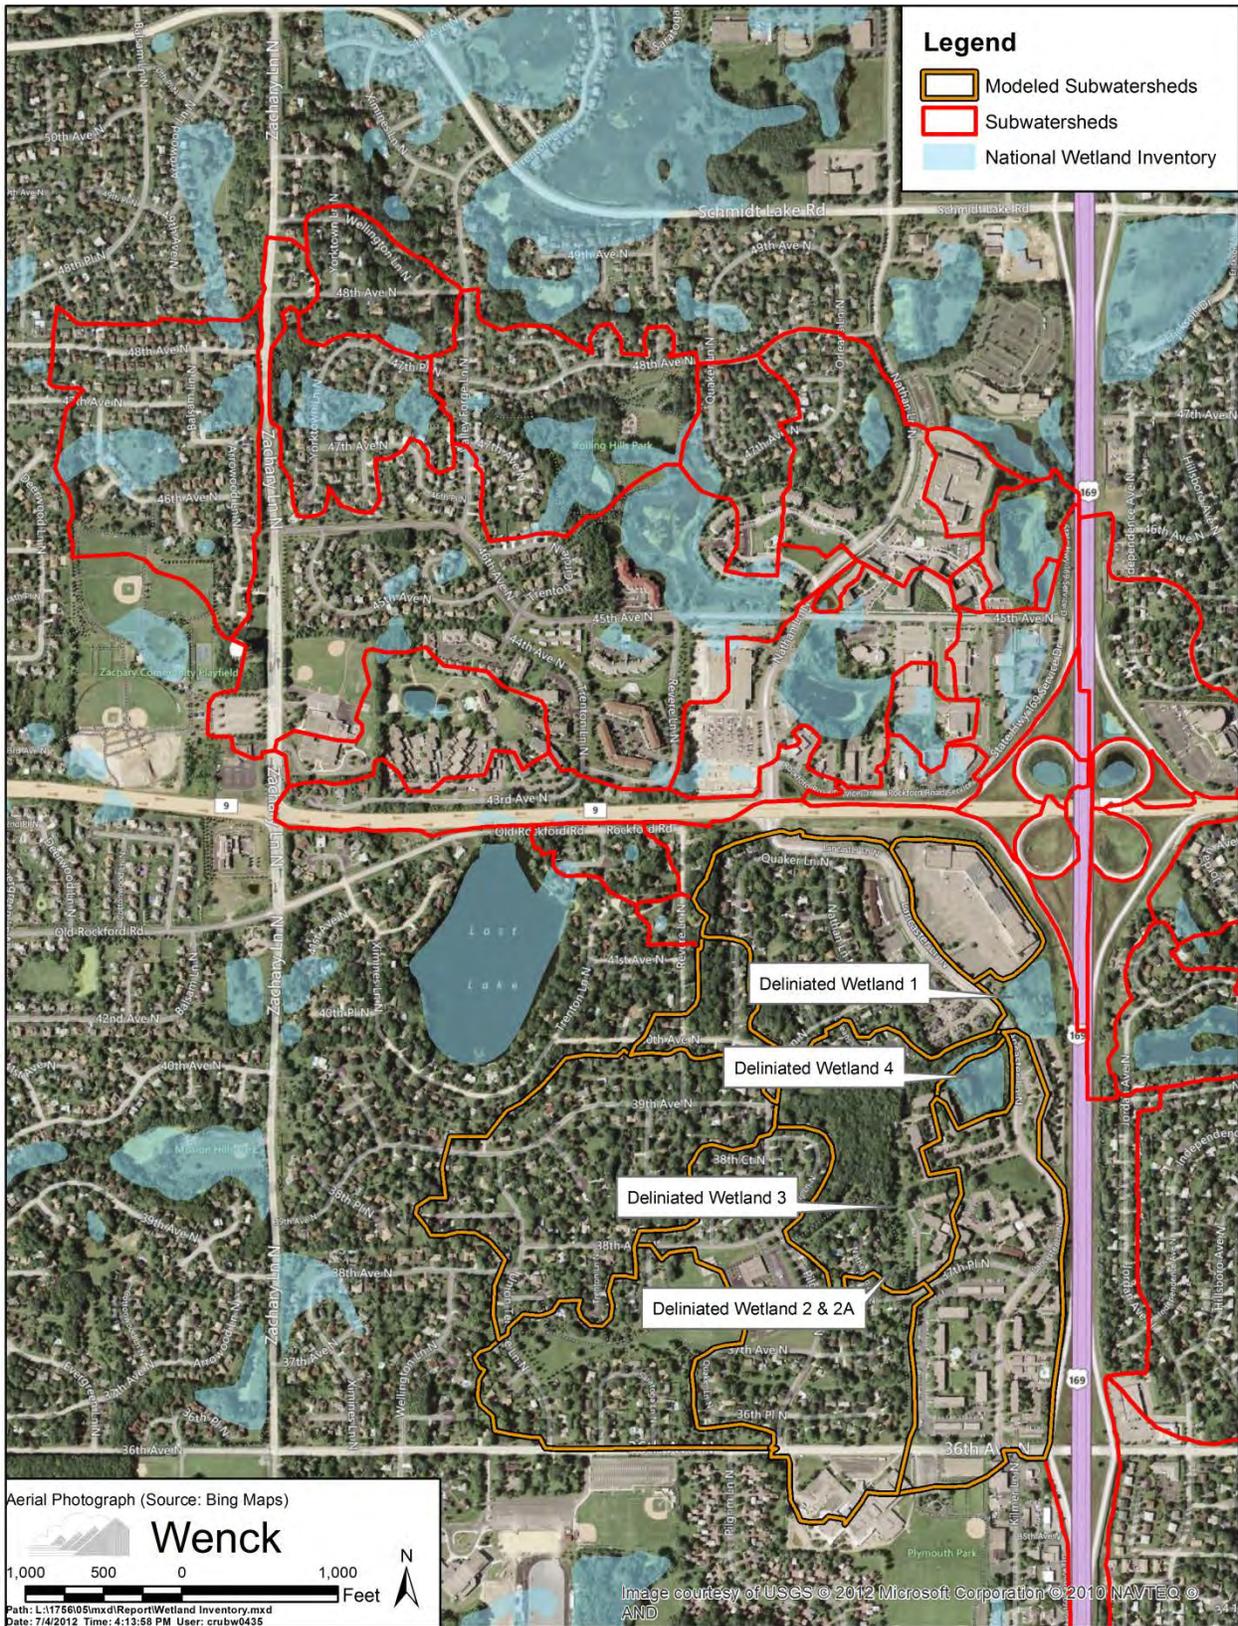
**Figure 2.4. Wetland Delineation within the Project Area.**

A wetland delineation report completed by Arrowhead Environmental Consulting (AEC) in 2011 identified five wetland basins in the project area (Figure 2.4). Wetlands 1 and 4 were also identified on the National Wetland Inventory (NWI) map. None of the wetlands are identified on the Minnesota Department of Natural Resources (MNDR) Public Water Inventory (PWI) map.

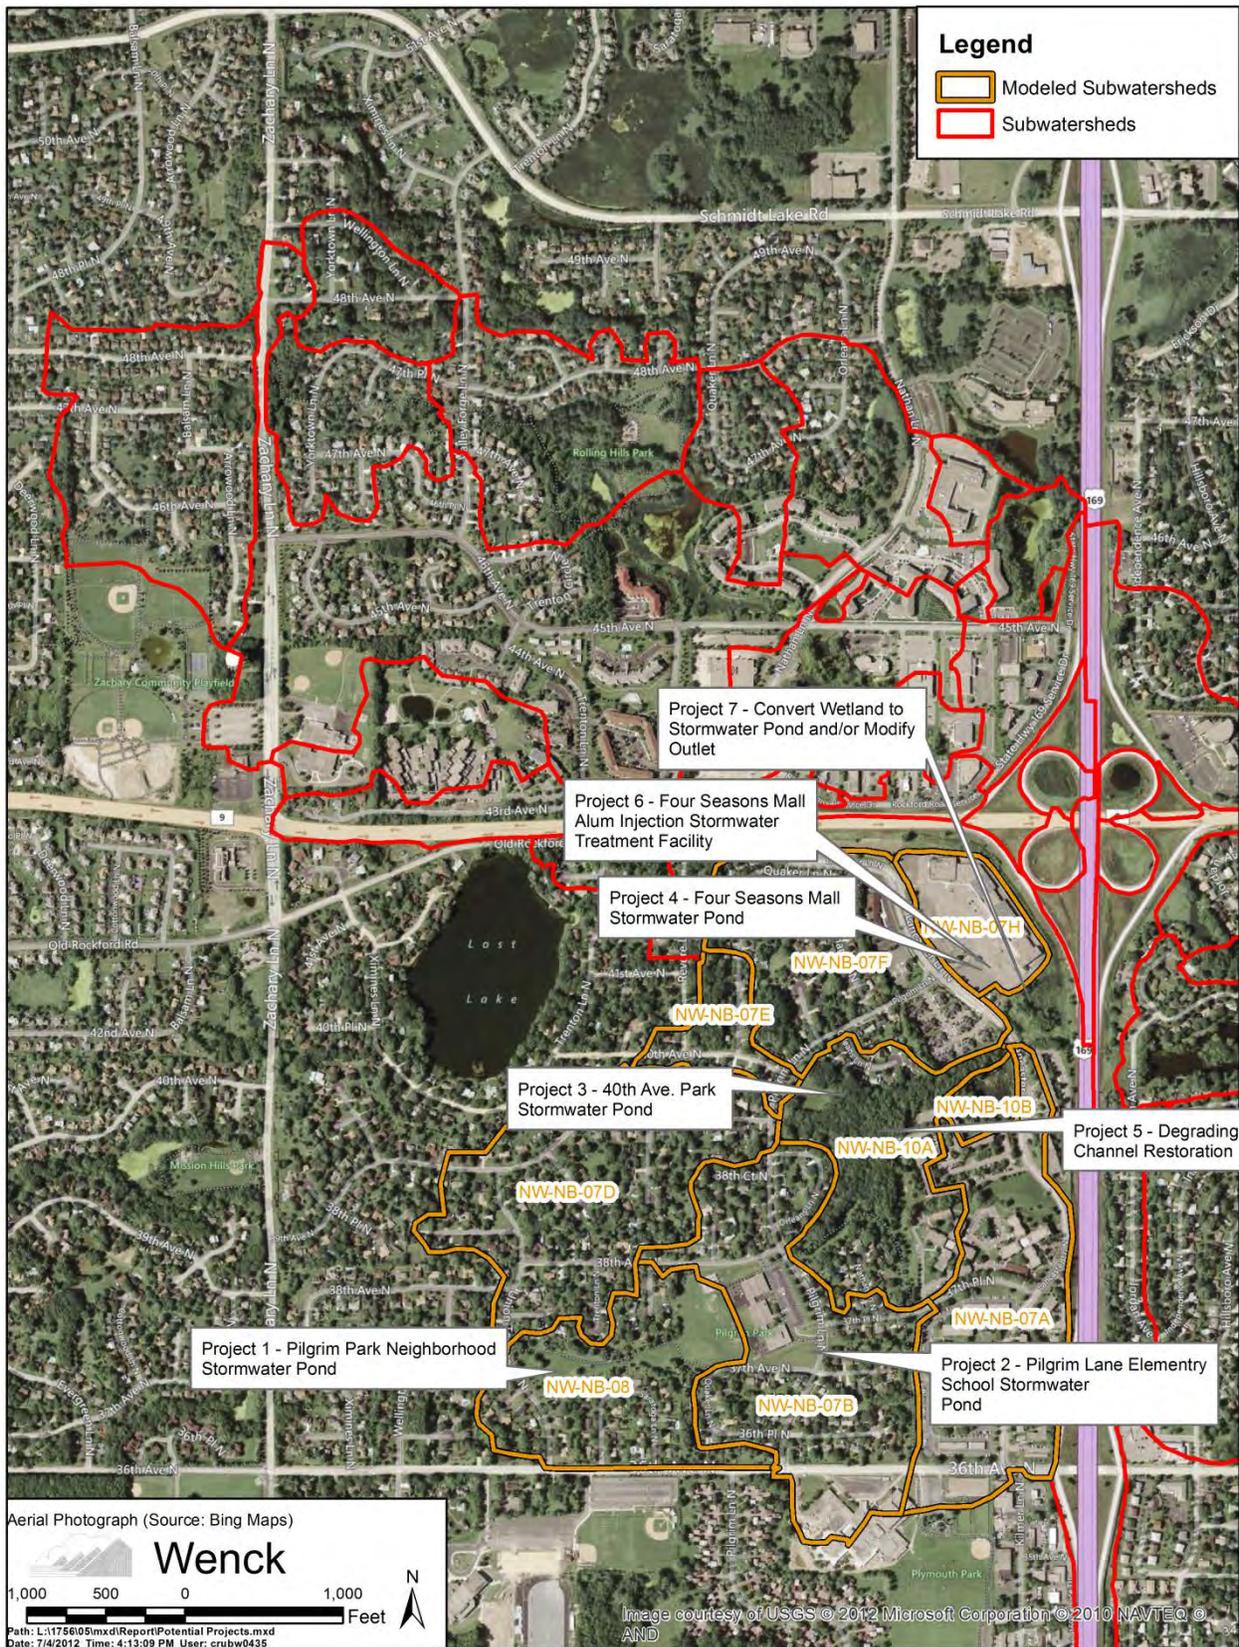
**Figure 3.1. Initial Project Identification Inventory.**

An initial list of projects was developed by reviewing watershed open space, land ownership, local soils, groundwater elevations, and other site specific conditions to guide the types of projects that are feasible for the area. A major constraint in the study area is space availability and land ownership. These constraints limited the areas of interest for ponding and filtration practices to open area parks located within the subwatershed, and the Four Seasons mall area itself. The initial projects identified in this first phase are shown in Figure 3.1 and briefly described as follows:

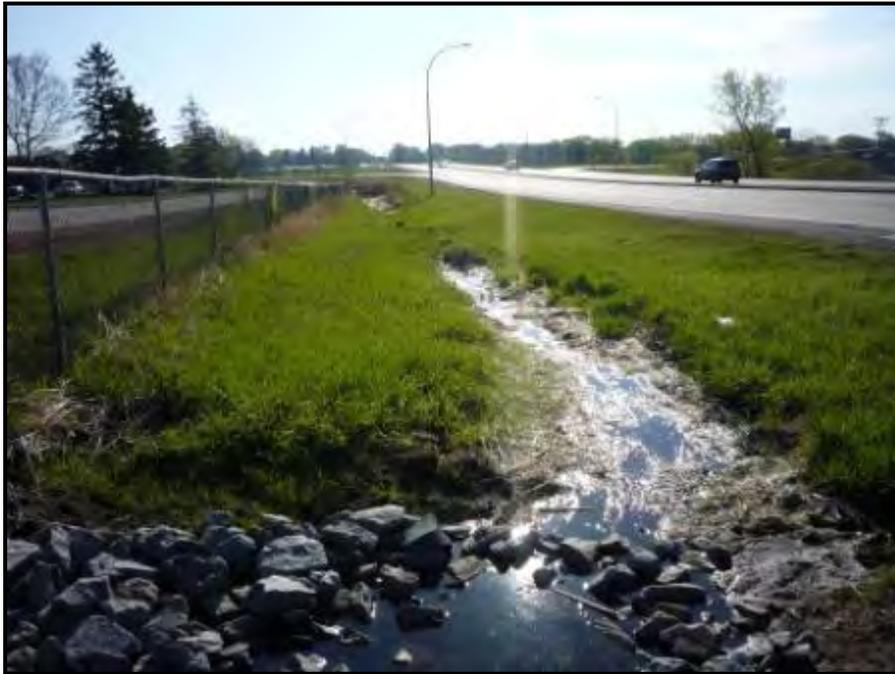
**Figure 3.2. Rockford Road Roadside Ditch.**  
Facing east from storm sewer outlet toward the connecting culvert directing flow towards the Four Seasons Mall.

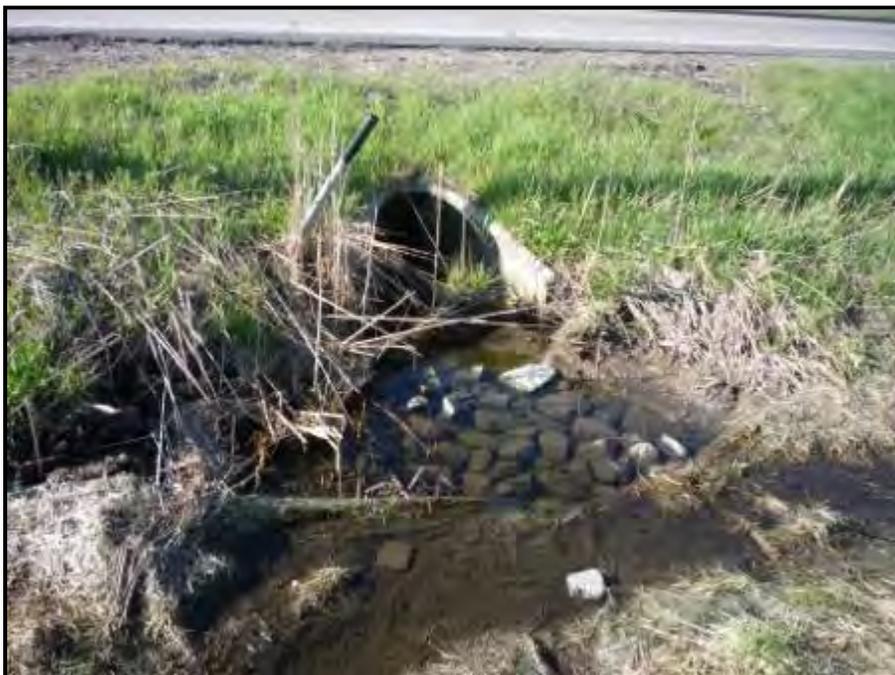
**Figure 3.3. 24 inch Reinforced Concrete Pipe.**  
Pipe leads flow from ditch to Four Seasons Mall delineated wetland area.

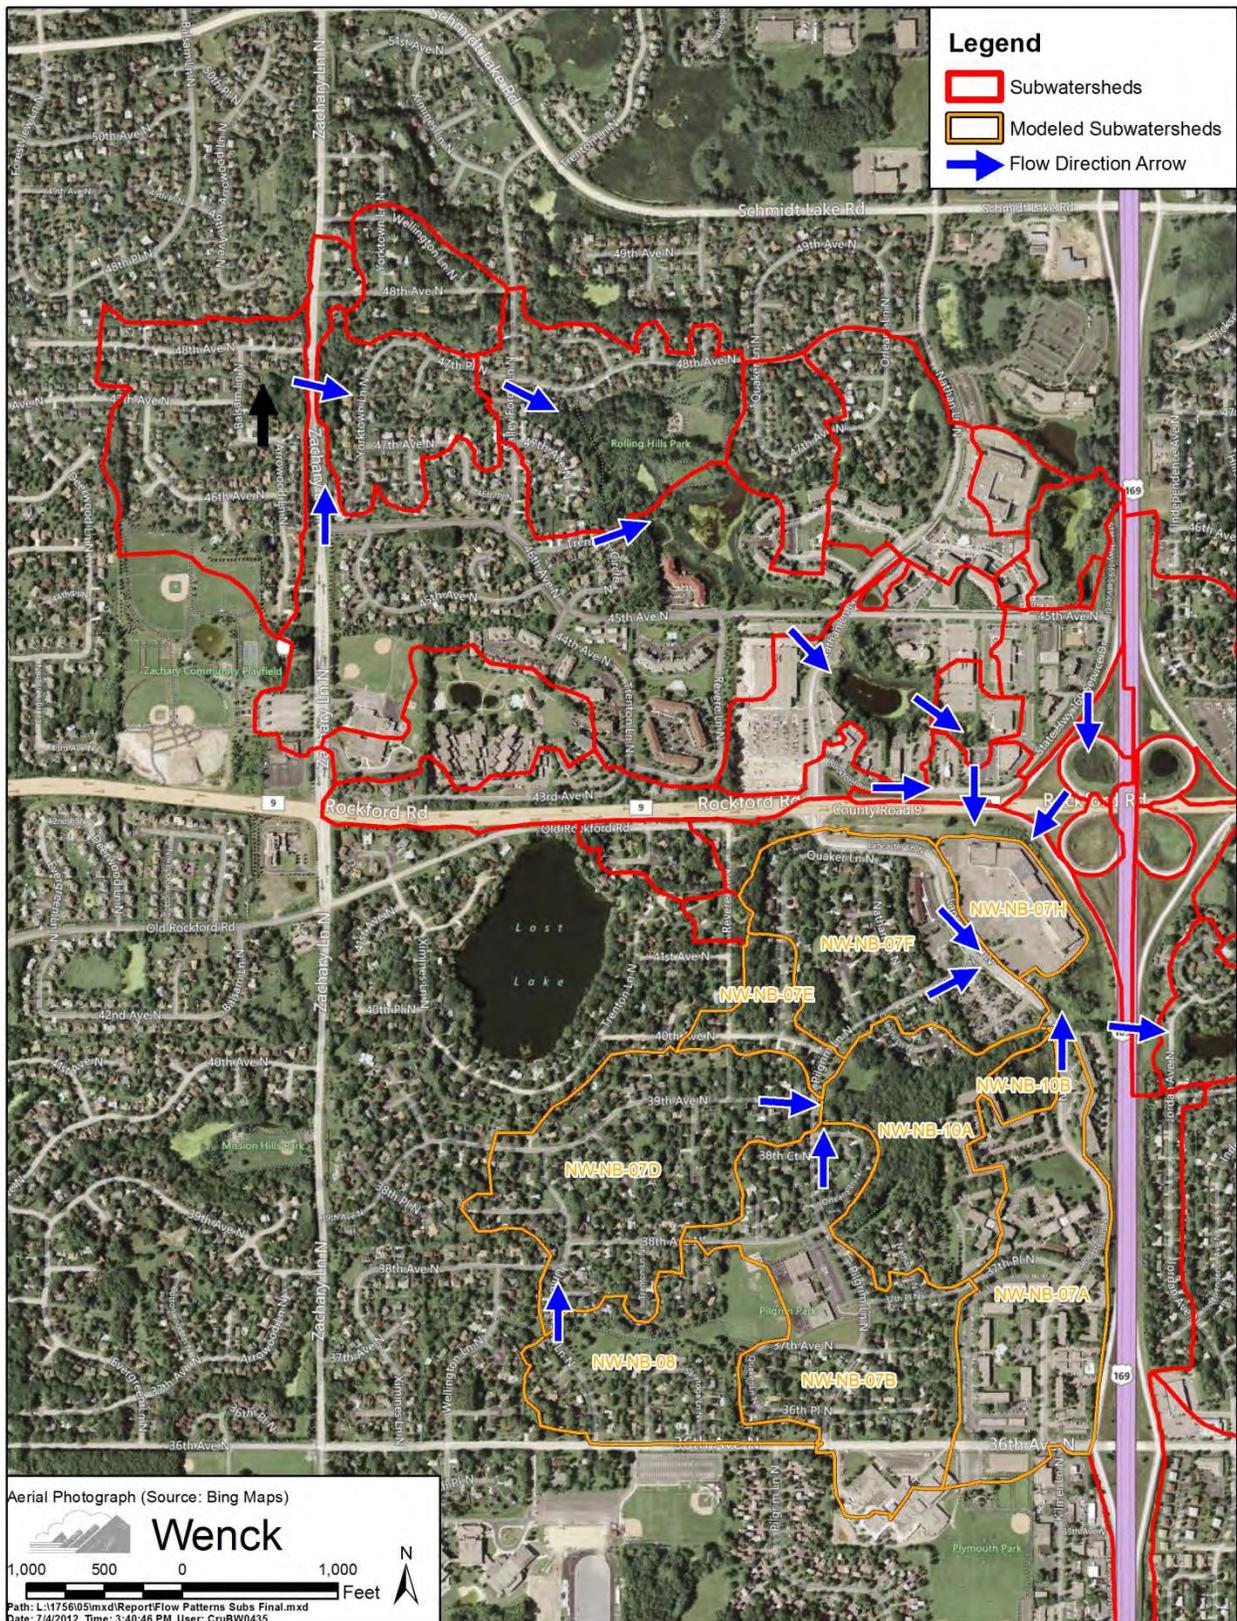
Figure 3.4. Subwatershed Flow Directions Identified.

The flow directions within the subwatershed indicating how the sewersheds are interconnected based on this overview of information and site survey are shown in Figure 3.4.

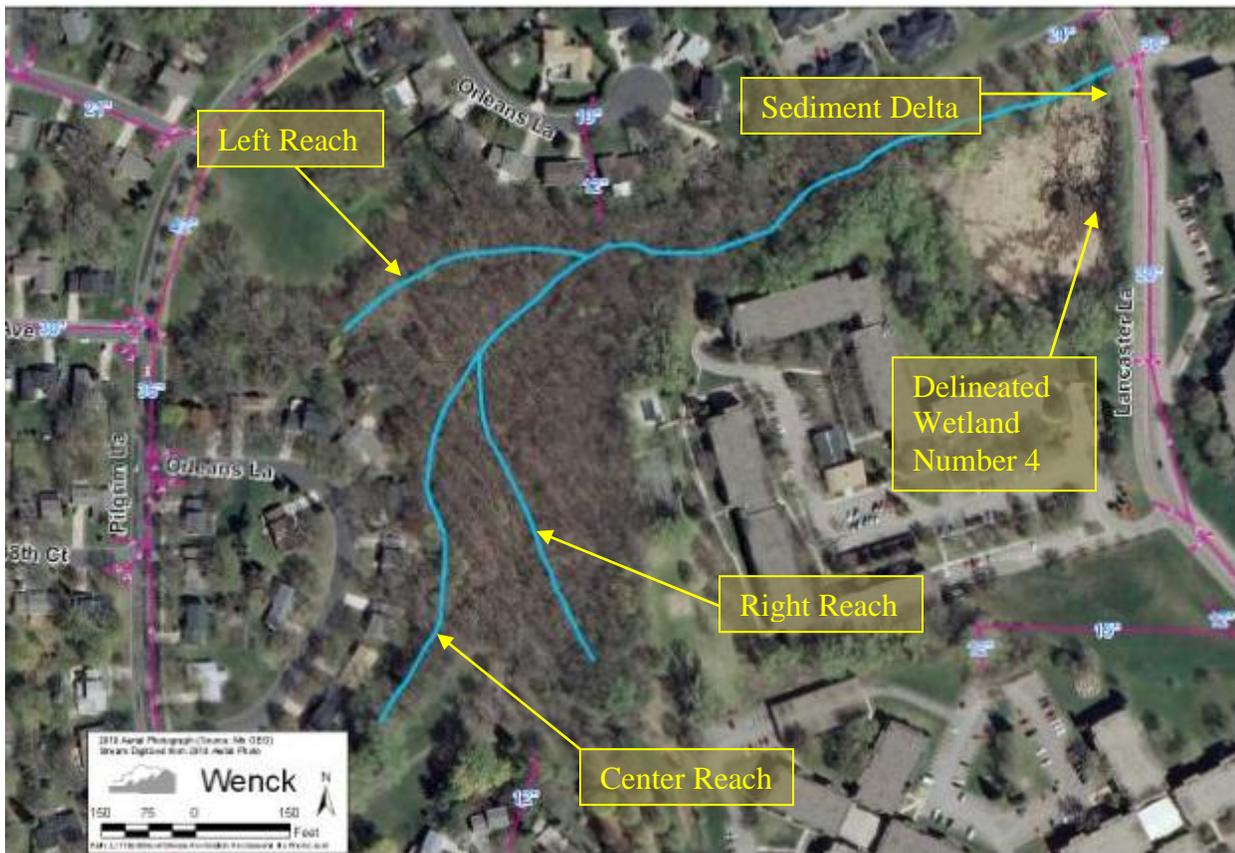
Figure 3.5. Channel Stabilization Investigation Reaches.

A series of channels flow west to east through city owned land between Pilgrim Lane and Lancaster Lane. These channels are in woods and discharge into the Lancaster Lane wetland (delineated wetland number 4) and then into Northwood Lake and the North Branch of Bassett Creek (see Figure 3.5). The Right Reach appears to be the primary channel, and conveys runoff from the adjacent commercial and residential areas, including runoff discharged from a 12” outfall from the Nathan Lane North cul-de-sac. The wooded area is at a lower elevation than the adjacent development to the north and west, and the Center and Left Reaches flow along the toe of a slope, conveying mainly overland flow. The three channels converge in the vicinity of a 12” outfall from the Orleans Lane North cul-de-sac.

Wenck conducted a visual inspection of these reaches to evaluate conditions and identify the nature and extent of any channel degradation and its probable cause. All three channels are experiencing erosion and mass wasting. The Right Reach is headcutting and widening. The channel is slightly meandered, with degradation of the outer banks and bare tree roots. The other two reaches are more stable, with areas of spot erosion. The 12” outfall from the Nathan Lane North cul-de-sac is broken, and the drainage swale to the Center Reach is scoured and unstable. The channel downstream of a 24” culvert under a trail crossing on the Center reach is scoured and downcut.

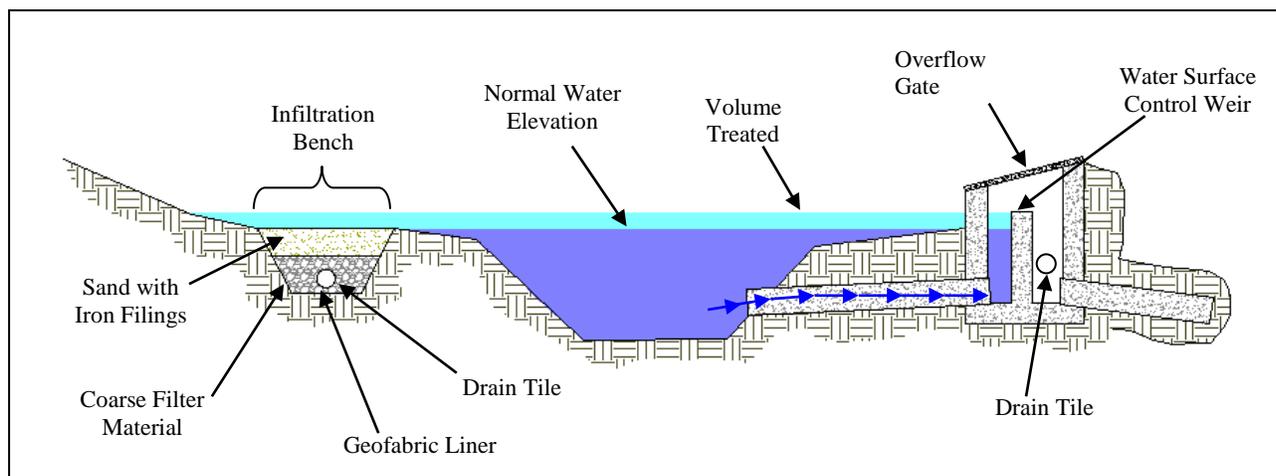
**Figure 5.1. Schematic of a Stormwater Pond with an Iron Enhanced Filter Bench.**

Scenario 1 includes two ponds located at strategic points in the watershed. These ponds were selected based on location in the watershed and land ownership. Both ponds incorporate iron enhanced filter benches in order to capture more of the dissolved fraction of total phosphorus. A typical cross section depicting the general layout of a pond with an iron enhanced filter bench is shown in Figure 5.1.

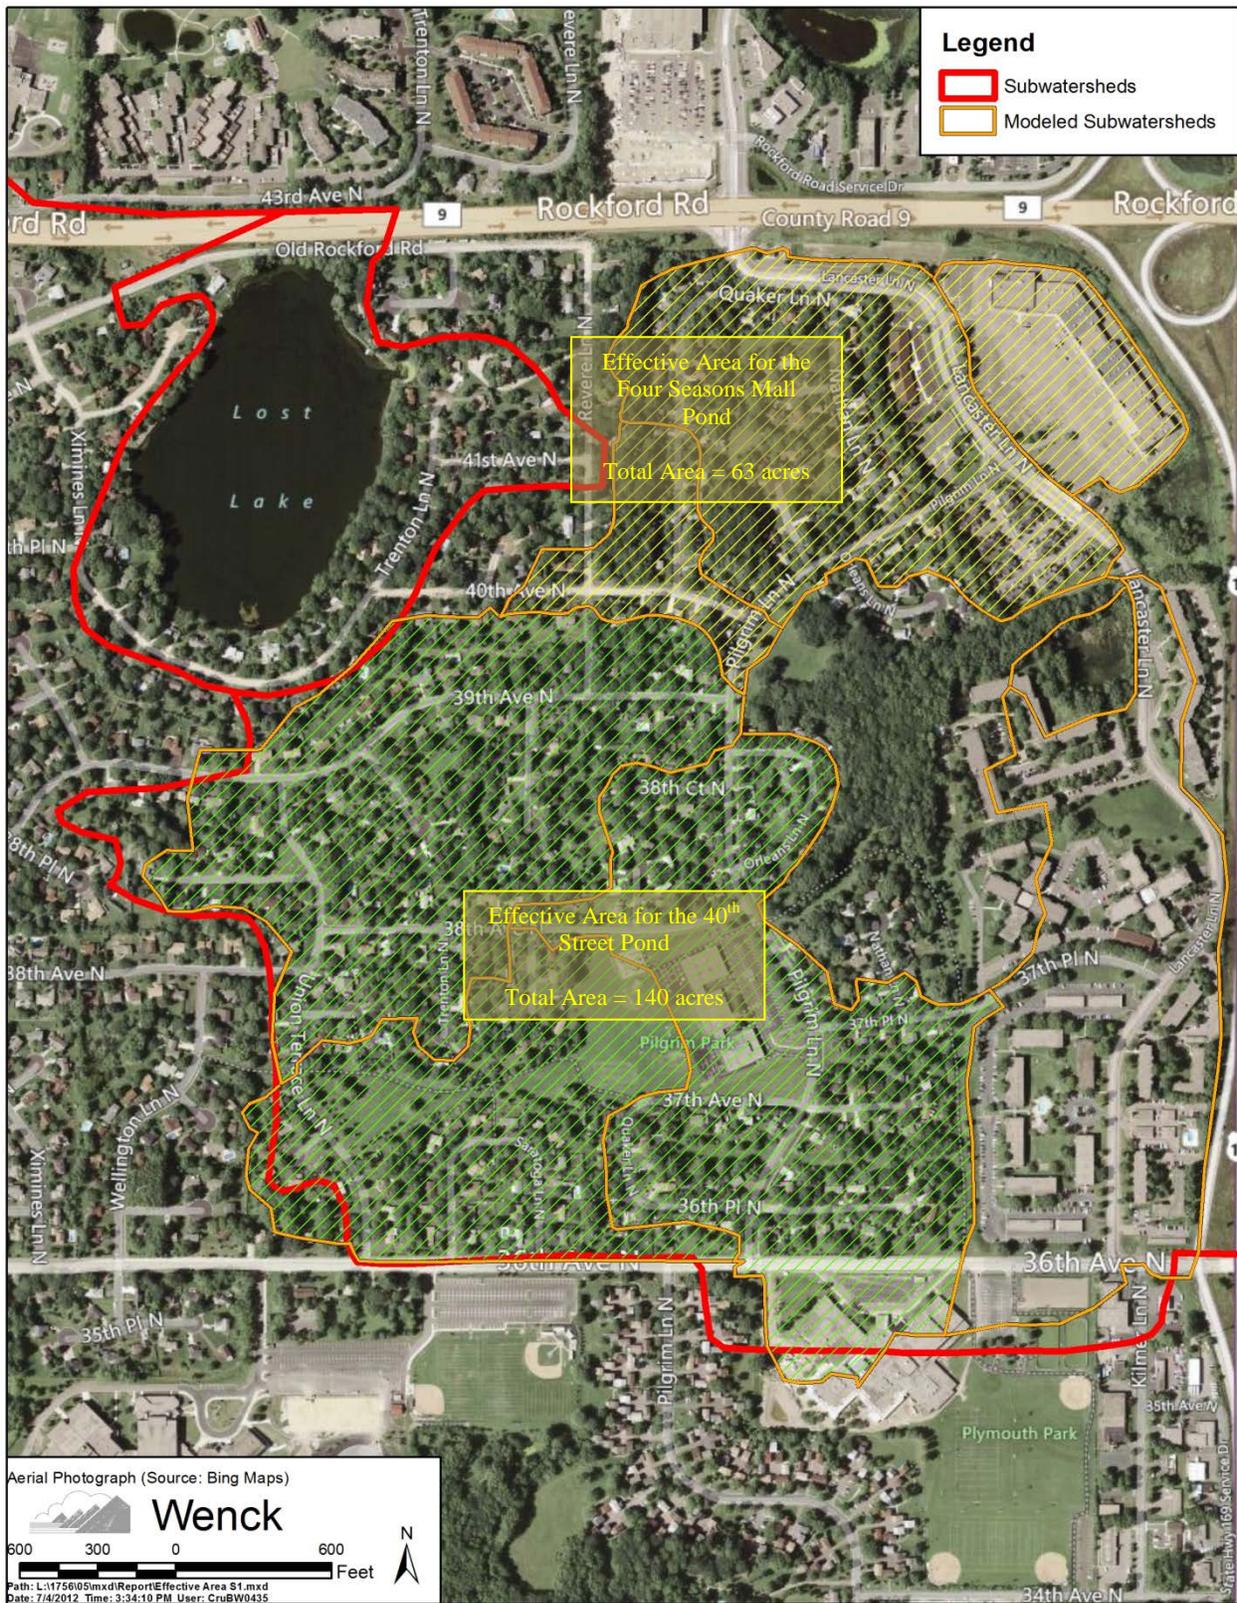
Figure 5.2. Effective Areas for Scenario 1 BMPs.

This project consists of installing a catch basin, flow splitter in line with the existing stormwater at the intersection of Pilgrim Lane and Lancaster Lane. The splitter will direct flows coming from the north along Lancaster Lane (47.1 acres of residential area from NW-NB-07E and NW-NB-07F) into a proposed pond located on the Four Seasons Mall Property. The existing parking lot drainage system is assumed to flow from the northwest side of the parking area towards the wetland (delineated wetland number 1, see Figure 2.4). As part of this project it is assumed that all of the impervious area from the Four Seasons Mall Property will be directed to the pond. The effective drainage area of 63 acres is shown in Figure 5.2.

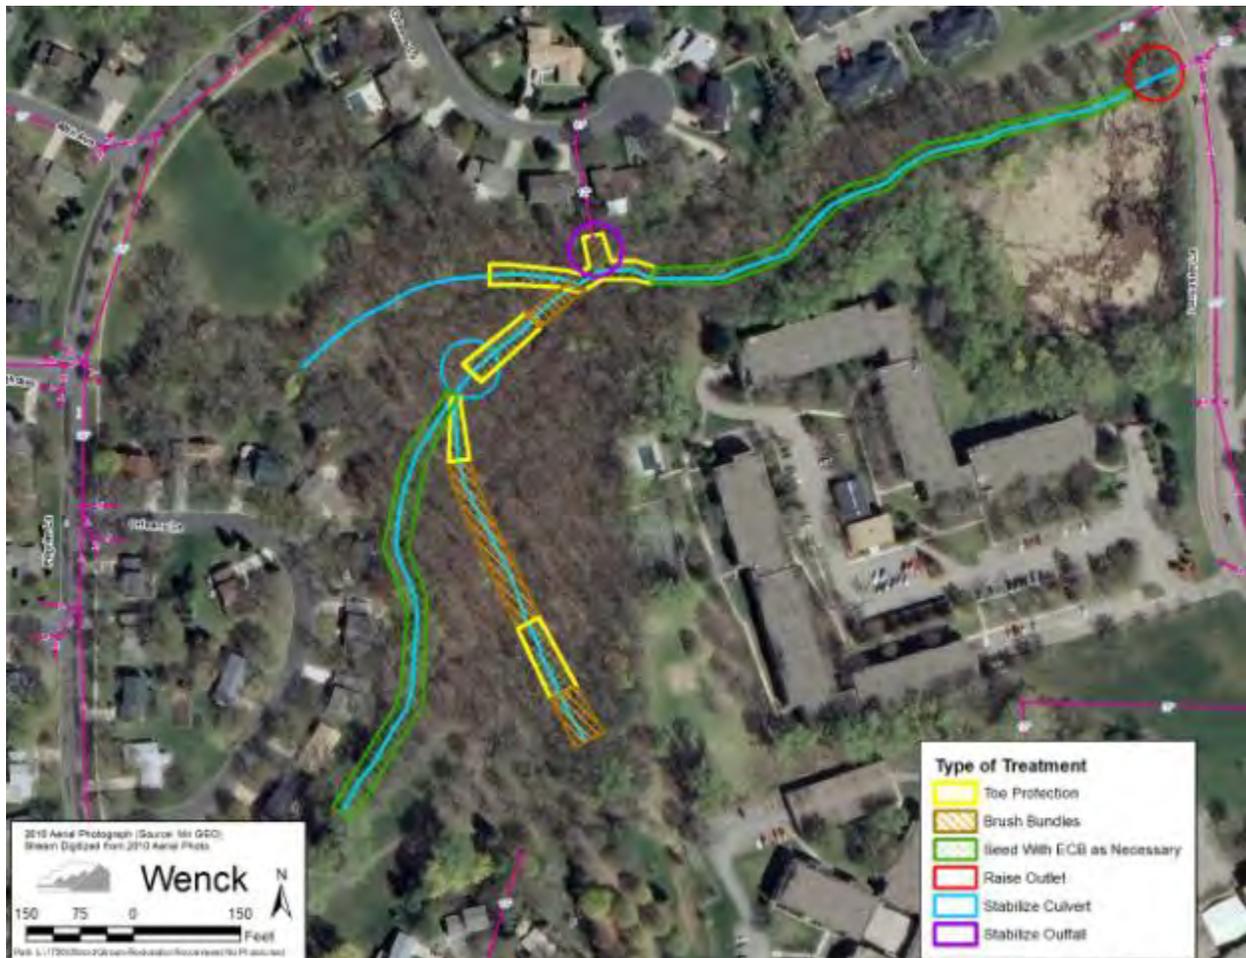
Figure 5.5. Conceptual Work Plan for the Stream Restoration Project.

There are approximately 2,375 linear feet of channel that would benefit from some type of improvement (Figure 5.5). Just less than 1,000 feet of channel are in relatively good condition and would benefit from simple tree and brush thinning, minor regrading, and planting a 30 foot wide buffer with mulched seed and native woody vegetation. An additional 500 feet of bank could be seeded and protected until vegetation establishment with an erosion control blanket on the slopes and mulch and woody vegetation in the buffer. About 325 linear feet has experienced some erosion and mass wasting which may continue if not stabilized. A treatment of tree thinning, brush bundles stacked on the streambanks, and native vegetation in a 30 foot buffer would be sufficient to stabilize the banks and filter overland runoff. Finally, about 570 linear feet appears to be actively eroding, and a boulder toe should be considered to provide stability, along with a native buffer. This includes areas downstream of culverts and outfalls as well as the streambank downstream of the proposed 47<sup>th</sup> Avenue Pond outlet.

Some segments of these channels are sloped at 0.05 or greater, and are headcutting. Each of the channels would benefit from installation of rock vane grade controls, at least one for every 2-3 feet of elevation change. Where there are steeper slopes and more headcutting, grade controls at every one foot elevation change should be considered.

One of the primary causes of channel degradation is the heavy tree canopy that shades the banks and prevents the growth of stabilizing long-rooted herbaceous and woody vegetation. Trees in the channel corridors should be thinned to open the canopy, and a 30 foot wide buffer established on each side of the channel.

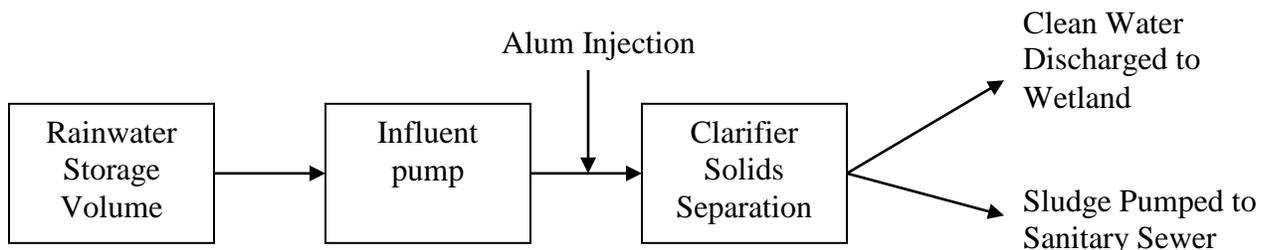
In general the chemical treatment train for the alum injection stormwater treatment system is described by the process flow diagram shown below.

Water will be pumped from the stormwater storage chambers to the clarifier through an influent pump station. The influent lift station consists of a precast concrete, 8-foot-diameter, 15-foot-deep structure, located near the stormwater storage system. The pump requirements include two pumps, operated in Lead/Lag (2 cfs or 900 gpm) and operated by level float switches. The forcemain to the clarifier would be 10 inch PVC pipe.

Before reaching the Clarifier Alum will be injected to the influent. The injections system includes a storage tank and a feed pump that has a start/stop mechanism based on run status of the influent lift station pumps. The estimated alum dosing rate is 10 ppm (but this needs to be verified by jar testing at project startup). The monthly chemical usage is to be determined with initial tests but is assumed to cost around \$5,000 per year including delivery to the site. The storage tank size necessary for the site is a 300 gal (this can be modified as needed based on jar testing results).

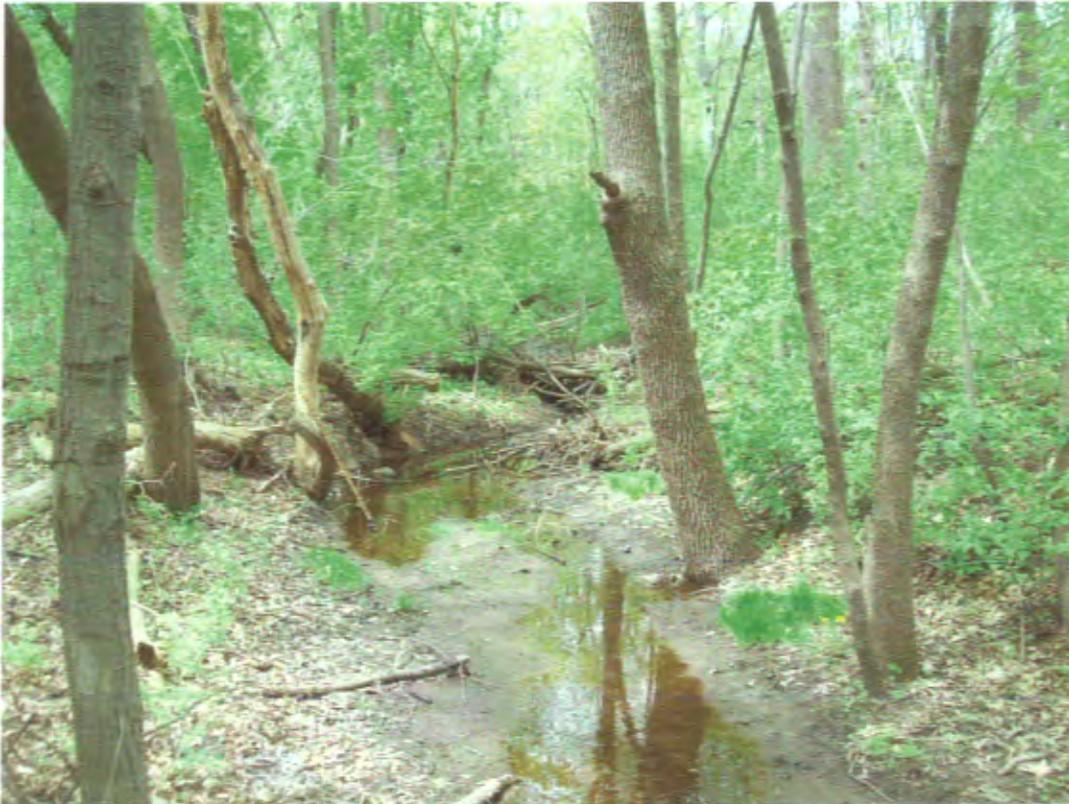
Photo 10: View of SP-A (drainage channel) facing west.

Throughout the forested area down-slope from Wetland 3 (and west of Wetland 4) AEC noted a number of highly eroded drainage channels (see Photo Log). These drainage channels convey water to Wetland 4 during spring time snow melt and after significant precipitation events. The forested area adjacent to the drainage ditches is dominated by basswood, common buckthorn, and green ash (*Fraxinus pennsylvanica*). A soil boring within the ditch indicated non-hydric soils as is typical in this setting. Flowing water was observed at the time of sampling however, flowage is likely temporary. These drainage ditch areas do not meet jurisdictional wetland criteria.
